Sheep River Intake Feasibility Assessment

Final Revision 0

Project No. 142001

Boreal Water Resources Ltd.
201 – 11 Fairway Drive N.W.
Edmonton, AB T6J 2W4

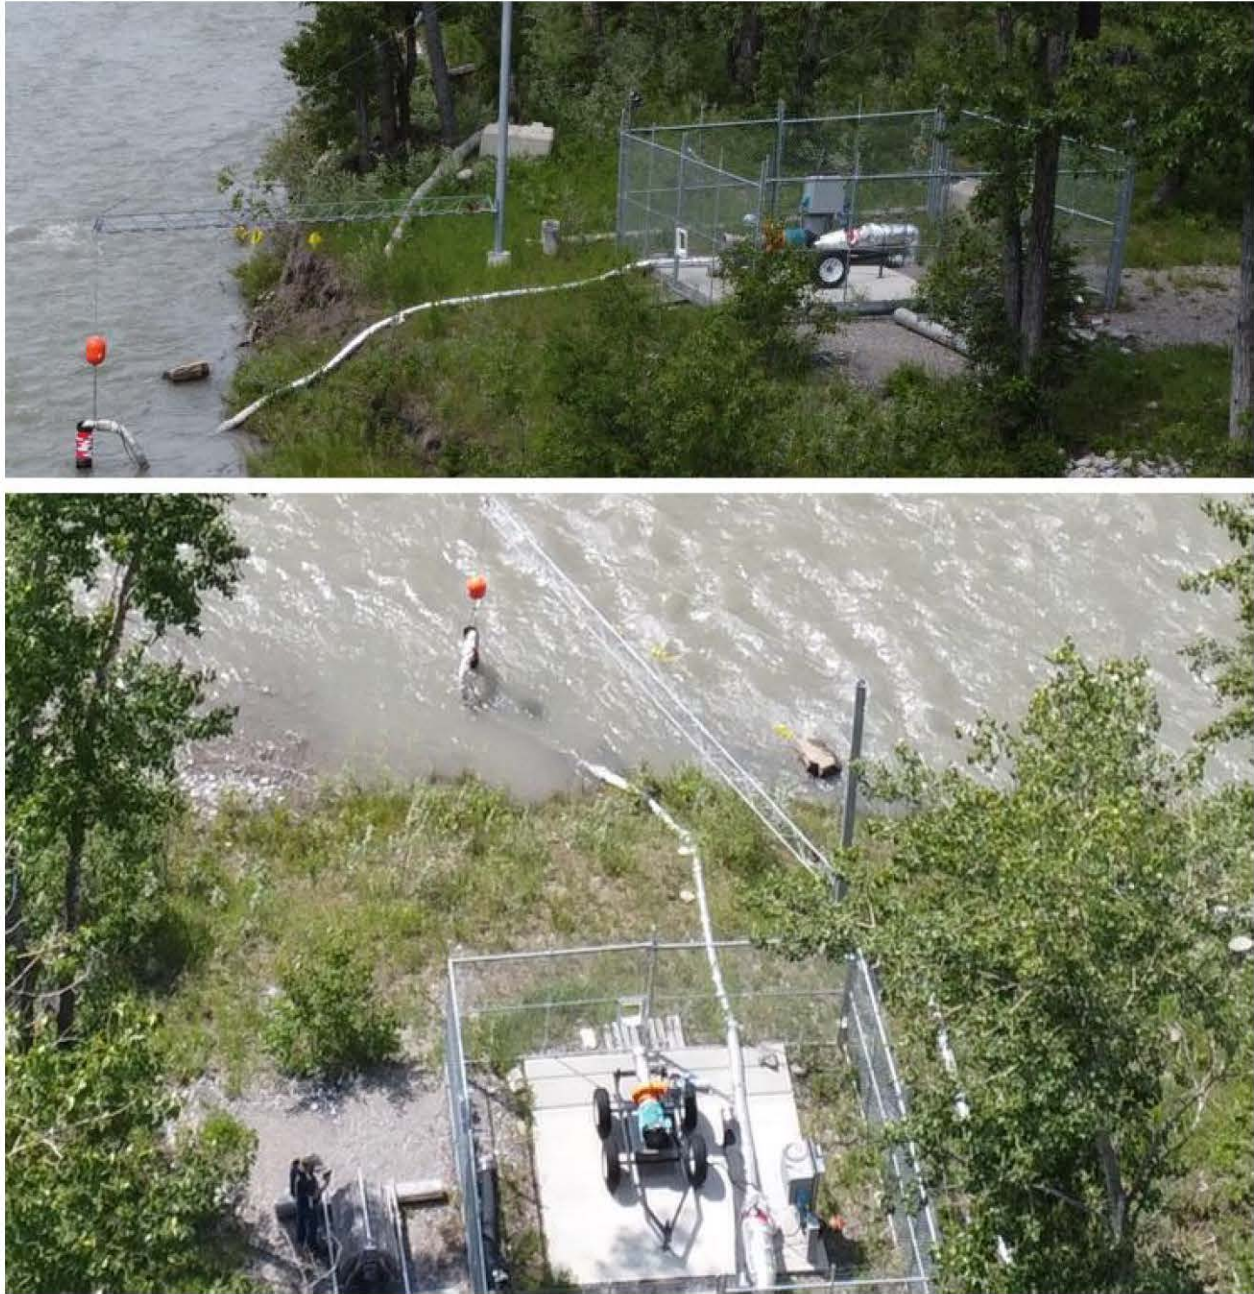
Figure 2: Temporary Intake on the Sheep River (June 26, 2024).

During Boreal's site visit completed on June 26, 2024, the Temporary Intake was deployed in the water but was not in operation (see **Figure 2**). The description provided above is consistent with Boreal's observations.

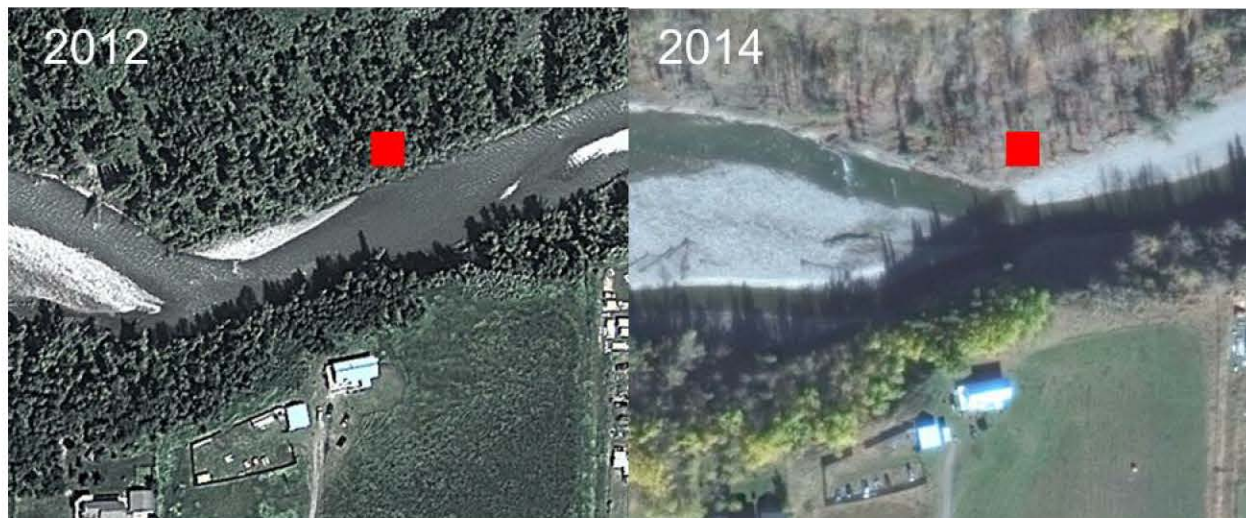
Figure 3: Location of the Temporary Intake.

Red squares indicate the location of the Temporary Intake. Image dates: left: July 20, 2012; right: October 9, 2014. Image source: Google Earth.

The Temporary Intake is located across from the downstream toe of a large medial bar. Upstream of this bar, flow divides into a north (left) channel and a south (right) channel, with the former receiving most of the flow. This has not always been the case: aerial photographs suggest that in the 1950s and early 1960s, the south channel was the dominant flow path. A reasonable hypothesis for this channel shift is that a significant flow event caused sediment aggradation to partially block the south channel, thereby pushing the flow to the north. Regardless of the cause, this shift has resulted in erosion along the left bank, including in the vicinity of the Temporary Intake. During the floods of 2013, the left bank immediately upstream of the Temporary Intake eroded approximately 35 to 40 meters forming the present bank-line, which is characterized by a 1.8 m vertical drop that is highly susceptible to future erosion. Given the scale of channel change during the 2013 flood event, it is reasonable to expect that the Temporary Intake is vulnerable to washing out during the next extreme flood event (see **Figure 3**).

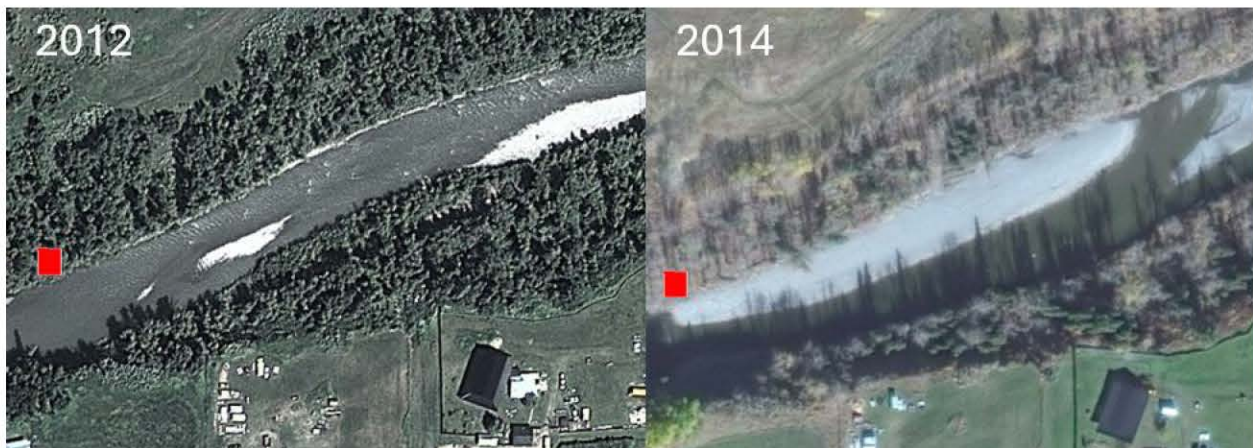
Figure 4 Segment 0+000 to 0+300 of the assessed reach.

Red squares indicate the location of the Temporary Intake. Image dates: left: July 20, 2012; right: October 9, 2014. Image source: Google Earth.

The north (left) bank in this area is characteristic of a depositional point bar with low-lying accumulations of gravels and cobbles (less than 8-inches in diameter) within a matrix of fine sands and silts. This bar is approximately 225 meters long and 25 meters wide and is moderately vegetated with a mix of shrubbery (silverberry and wolf willow), balsam, and poplar with some red willow and clover. On the upslope side of this bar is a two-meter-high vertical rise to the adjacent terrain, likely formed in 2013 during the extreme flood event that impacted the river.

The river channel itself is straight and appears to be relatively stable. The 2013 extreme flood event appears to have re-distributed bedload accumulations within the channel, though this appears to have stabilized since that time. Bathymetric survey procured by MPE indicates that the channel is relatively flat and wide, with depths approaching one meter over a 20-to-25-meter wetted width. The channel thalweg appears to be marginally deeper on the right side of the channel as one might expect given the trajectory of the slight bend in the river at this location.

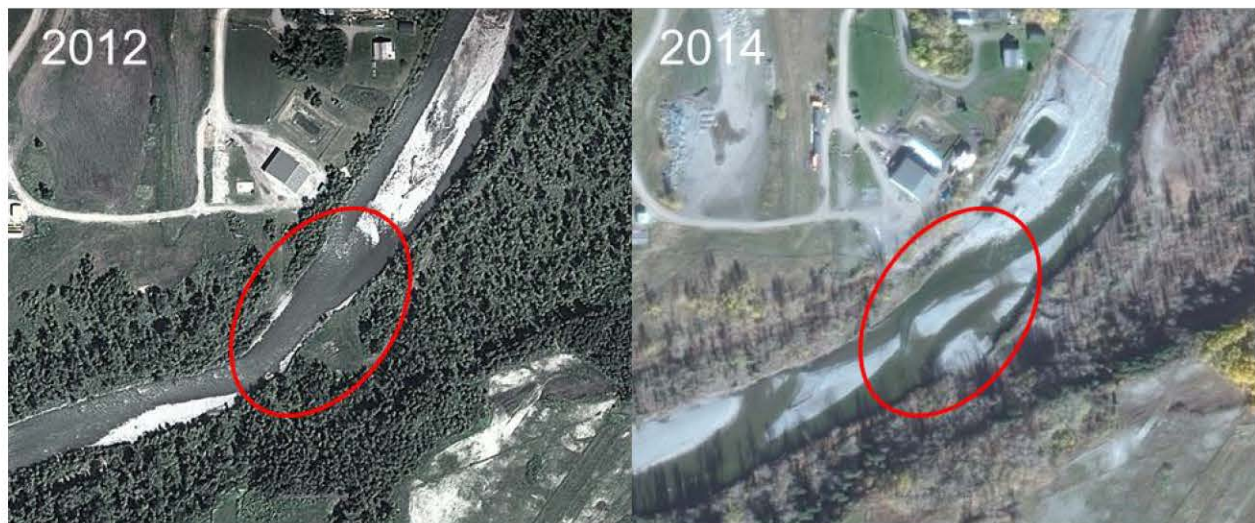
Figure 5: Location of direct infiltration intake proposed by NHC (1998).

Red ovals indicate the approximate location of the proposed intake. Image dates: left: July 20, 2012; right: October 9, 2014. Image source: Google Earth.

As noted in Section 2.1, NHC (1998) had proposed a location for a direct infiltration intake to the south of the present-day WTP. This location is shown in **Figure 5**, which highlights the significant movement that had occurred during the 2013 flood event. It can be seen that prior to the 2013 event, the dominant channel flowed along the left bank adjacent to the WTP, which then flipped to the right side after the event. Had a direct infiltration intake been constructed at this location, it is likely that a major maintenance program would have been required to re-establish the filtration media and to ensure that the intake's pipes remain wetted.

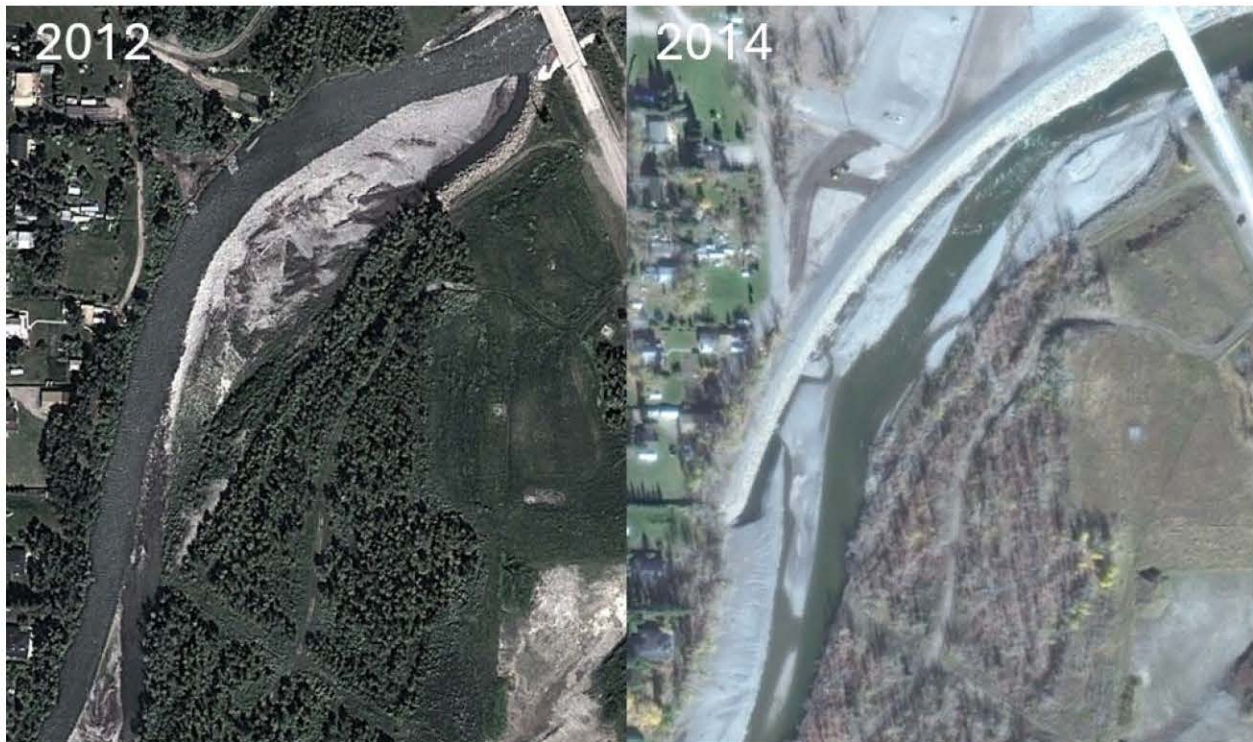
Figure 6 Segment 0+450 to 1+070 of the assessed reach.

As shown in the **Figure 6**, significant changes occurred on both the inner and outer sides of the reach near the bridge between 2012 and 2014. The outer bend was stabilized with riprap, halting erosion and preventing further migration. As a result of these stabilization efforts, the alignment of the main channel has

remained relatively constant since 2014, with large deposits of fine and coarse materials on both banks of the river.

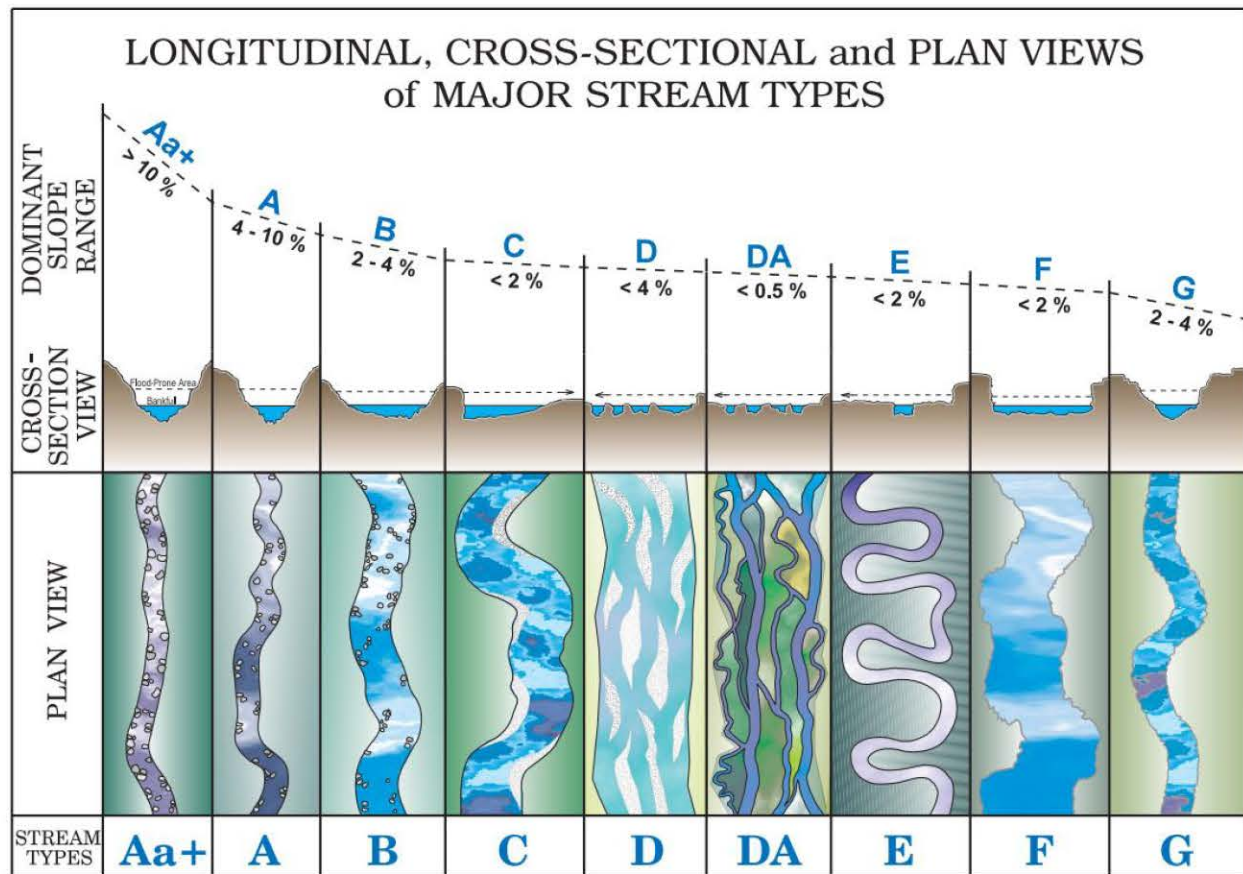
Figure 7: Schematic stream types (Rosgen, 1994).

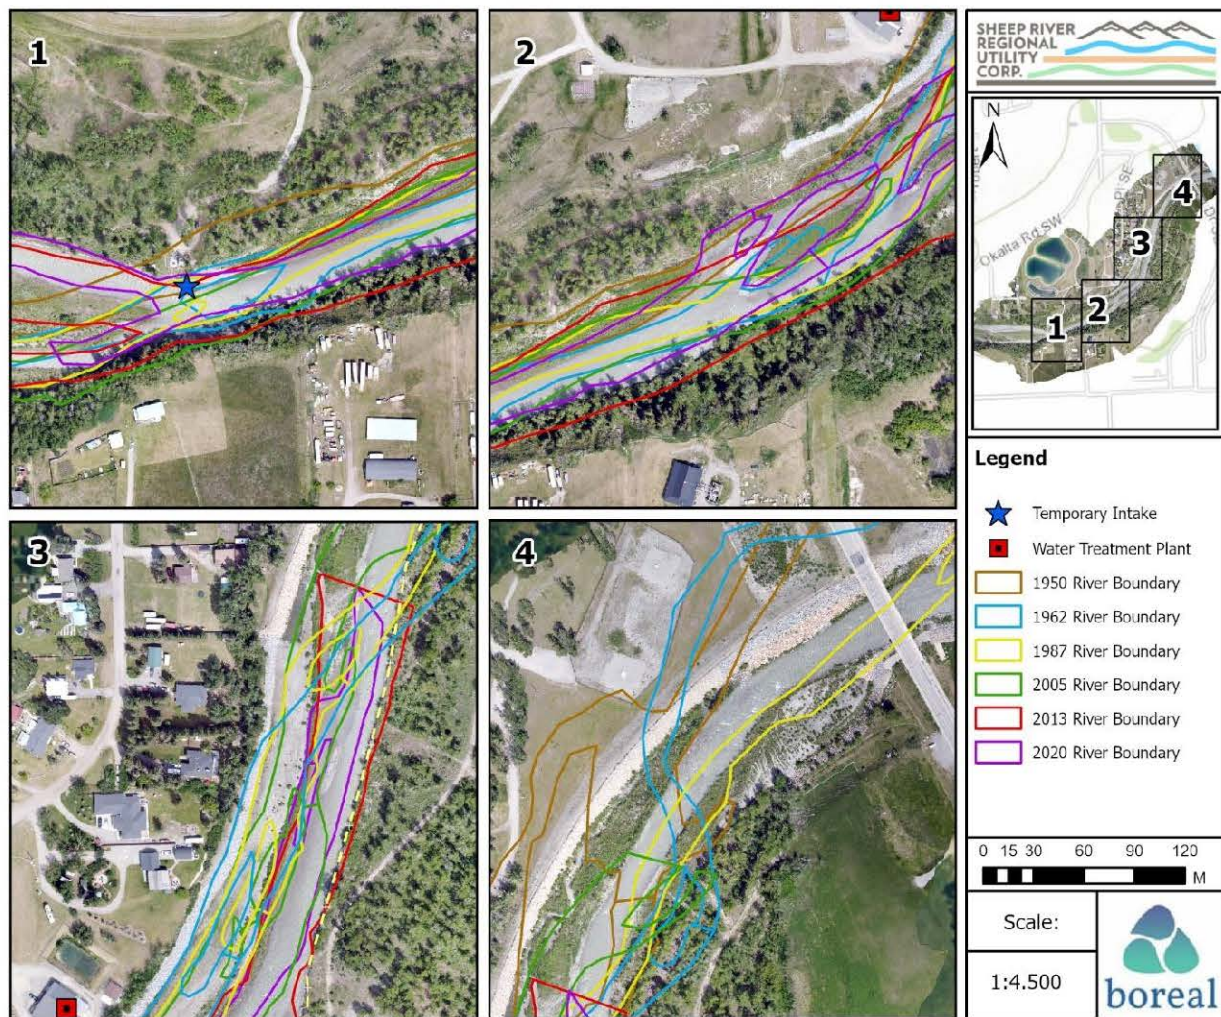
Figure 8: Multi-Temporal Analysis with Every Year.

A multitemporal analysis was performed with aerial images from 1950 through 2020. These images reveal the high dynamism of this reach. The observed behavior of the reach aligns with its classification, as highly dynamic environments are common for wandering rivers in foothill regions (see **Figure 8**). **Appendix A** provides more detail each year with the corresponding aerial imagery.

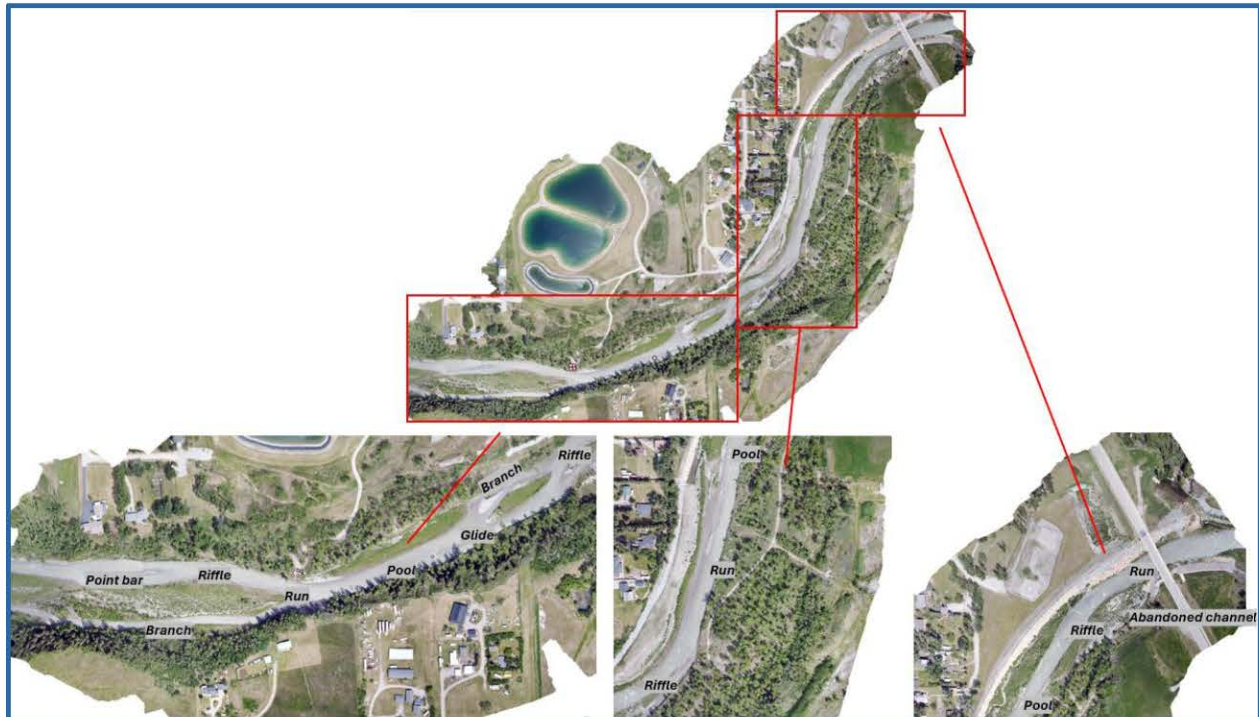
Figure 9: Assessed reach flow habits.

Figure 9 shows the bed forms within the study reach, such as: point bars, branches, abandoned channels, riffles, runs, pools and glides. The most notable example of river dynamics can be observed approximately 20 meters upstream from the Temporary Intake. Here, the main channel of the river has experienced significant lateral migration to the north, with a displacement of approximately 30 meters. Currently, the left bank of the river at this point shows significant signs of erosion.

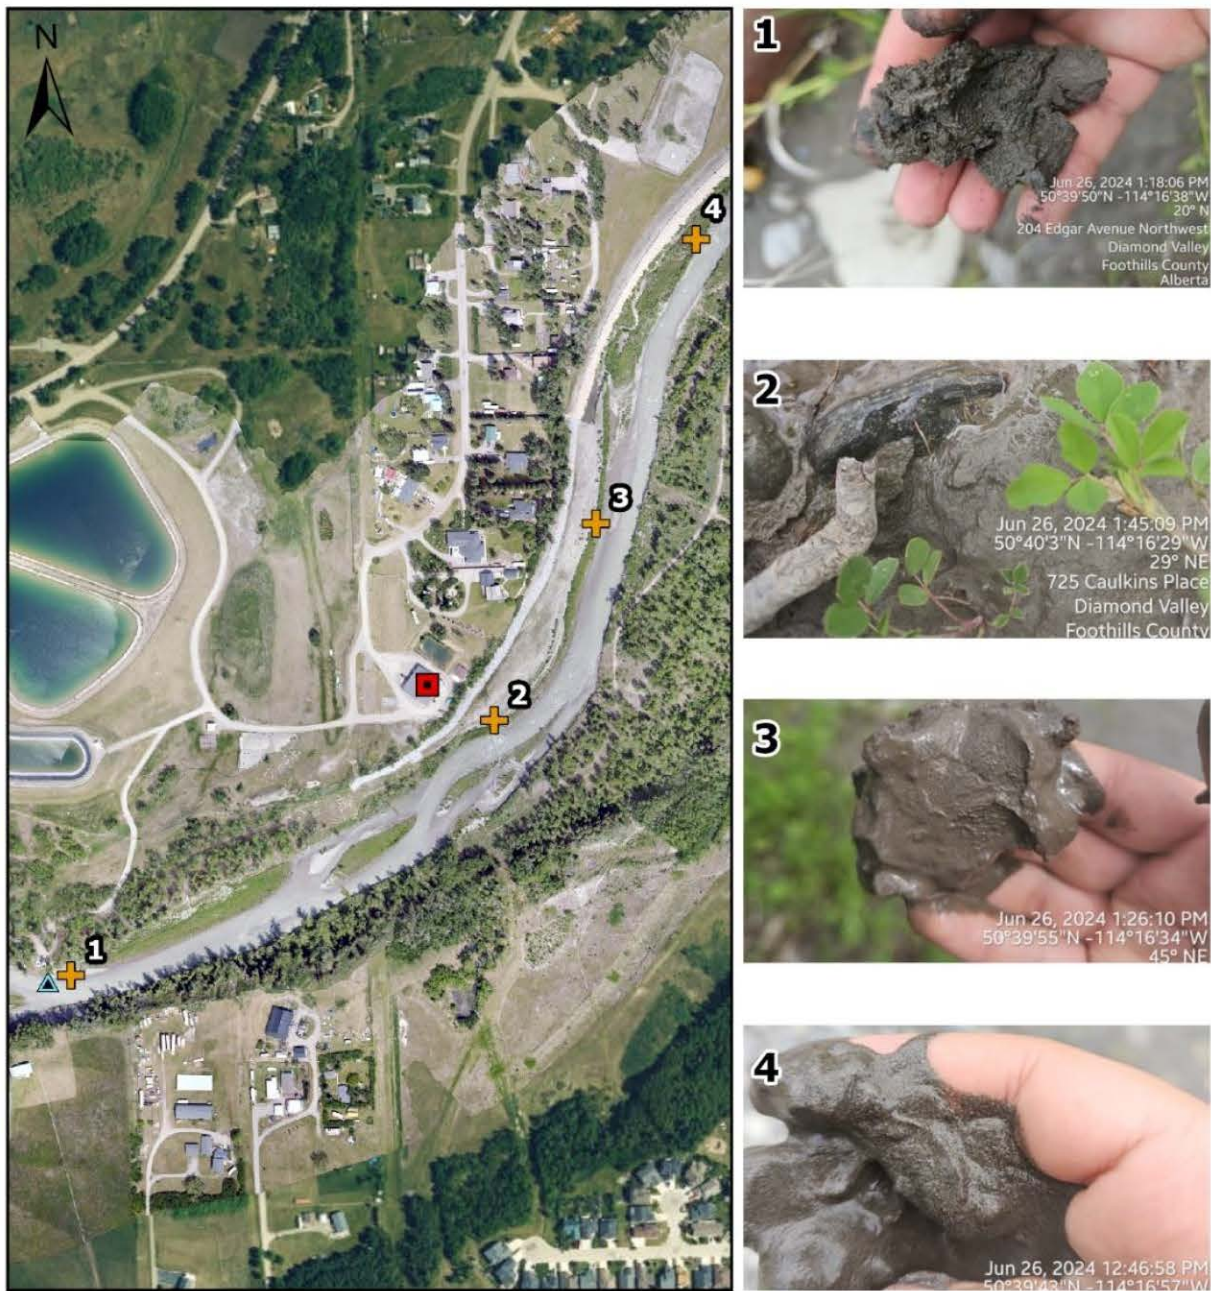
Figure 10: Typical sediments encountered during the site visit.

This river exhibits a high degree of sediment dynamics, as observed during the site visit. Sediment deposition includes a wide range of particle sizes, attributed to the river's riffle-pool morphology and variable flows. Large boulders and riverbank protection works suggest strong erosive forces during high-stage conditions, while the presence of fine sediments along the banks indicates significant fine sediment deposition during lower flows.

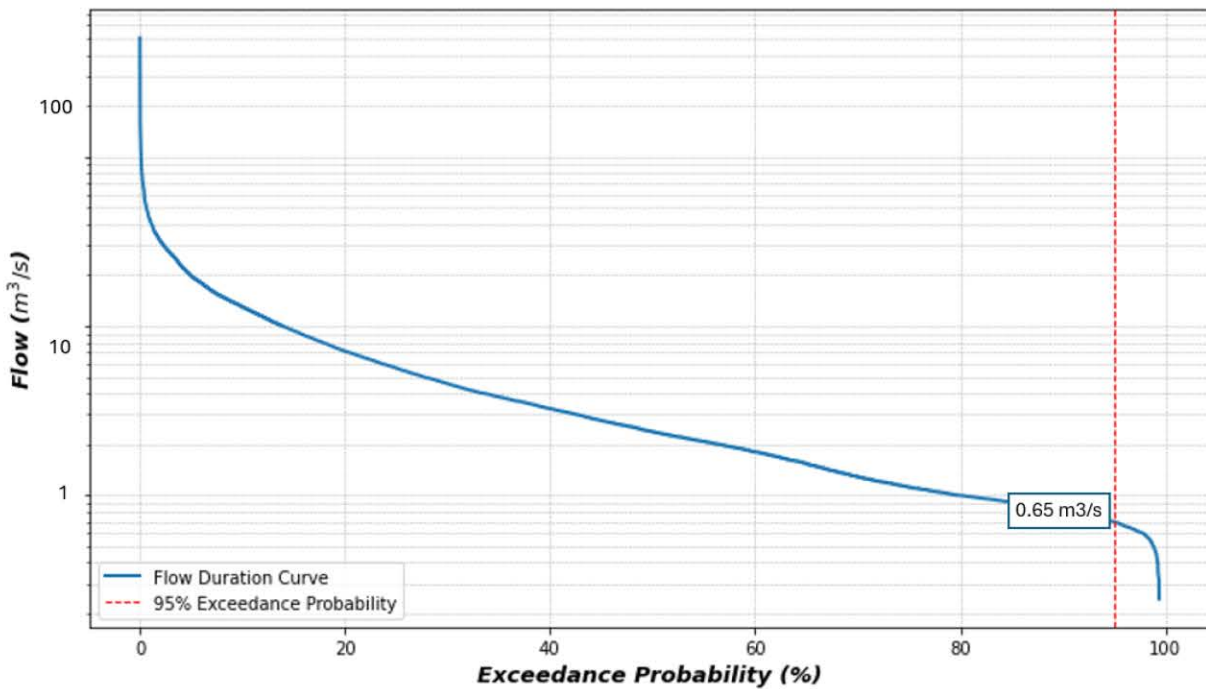
Figure 11: Annual flow duration curve for Sheep River at the Study Reach.

A Flow Duration Curve (FDC) (see **Figure 11**) and box-and-whiskers plot (see **Figure 12**, and **Figure 13**) were developed to visualize the flow regime in Sheep River at the *Sheep River at Black Diamond* station. A key parameter utilized in this assessment is the annual Q95 estimate, which represents the river flow that is met or exceeded for 95% of the year. This metric was deemed appropriate for evaluating permanent intake options from the context of year-round operability.

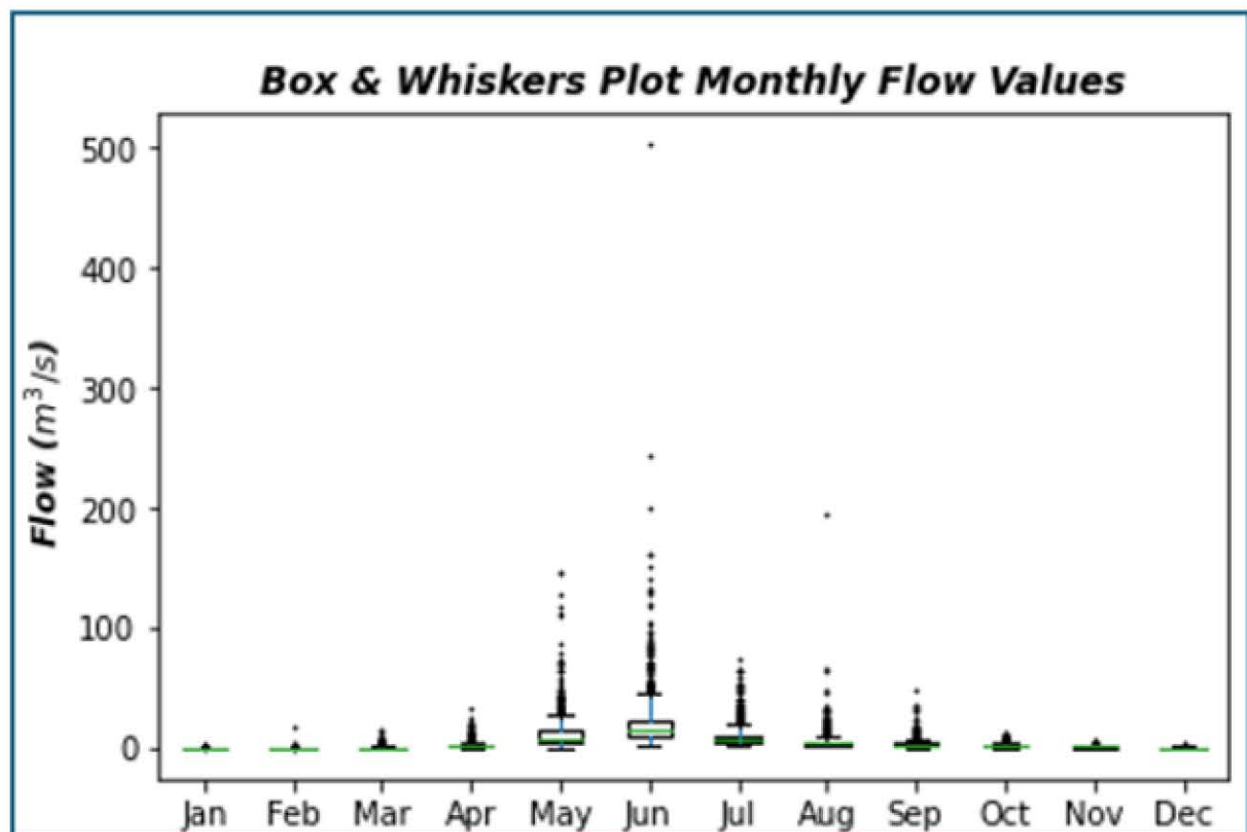
Figure 12: Box-and-whiskers plot of monthly flows at the Study Reach.

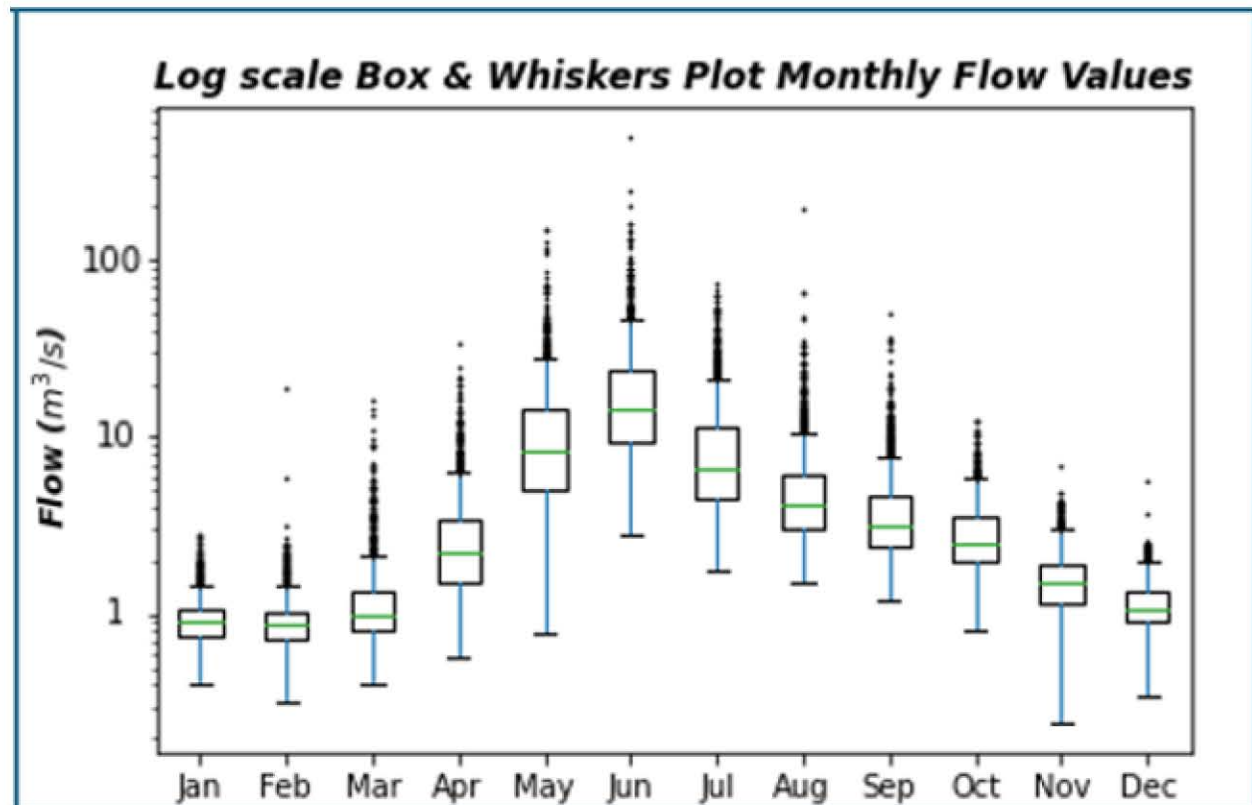
Figure 13: Box-and-whiskers plot of monthly flows in logarithmic scale at the Study Reach.

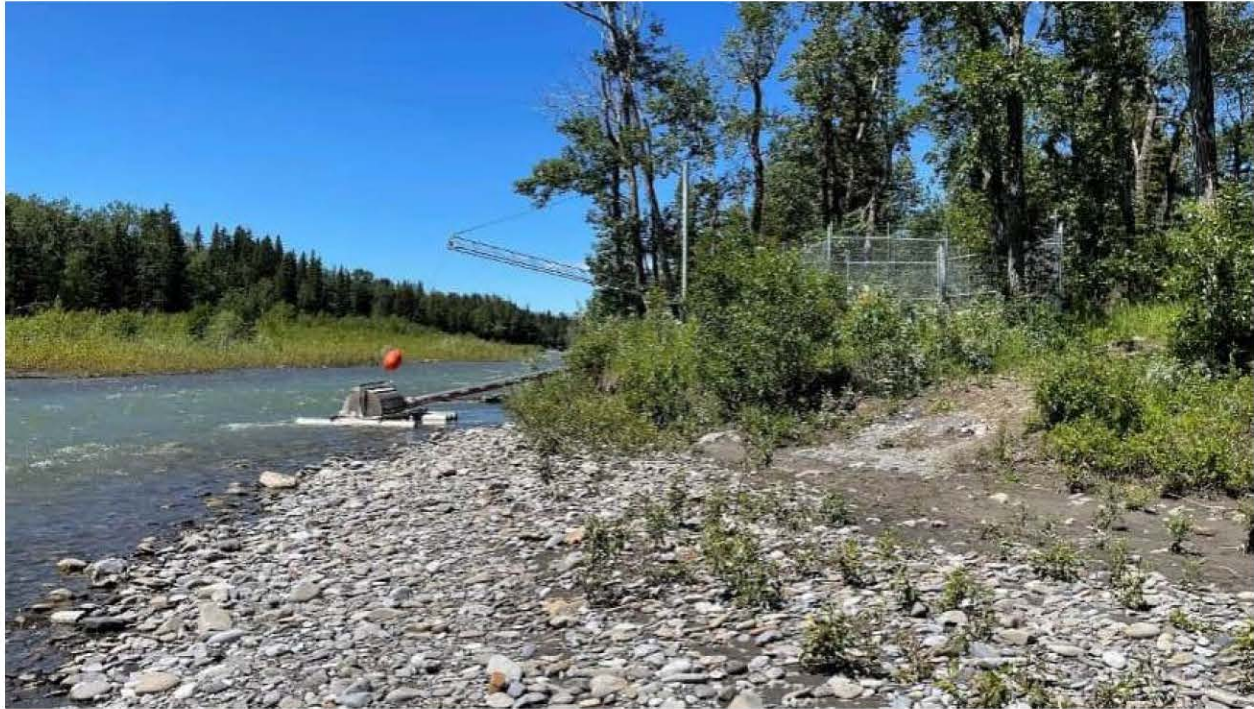
Figure 14: SRRUC's Temporary Intake on the Sheep River.

The existing Temporary Intake (see **Figure 14**) consists of a submerged intake screen within a buoyant protection structure that can be deployed or removed as operations require. Presently, SRRUC deploys the intake in the early-summer and removes it prior to freeze up. It is understood that operations staff try not to use the intake during the freshet to minimize the amount of entrained sediment that is pumped to the retention ponds; instead, the intake is used more frequently in the late-summer and fall periods when the river water is clearer.

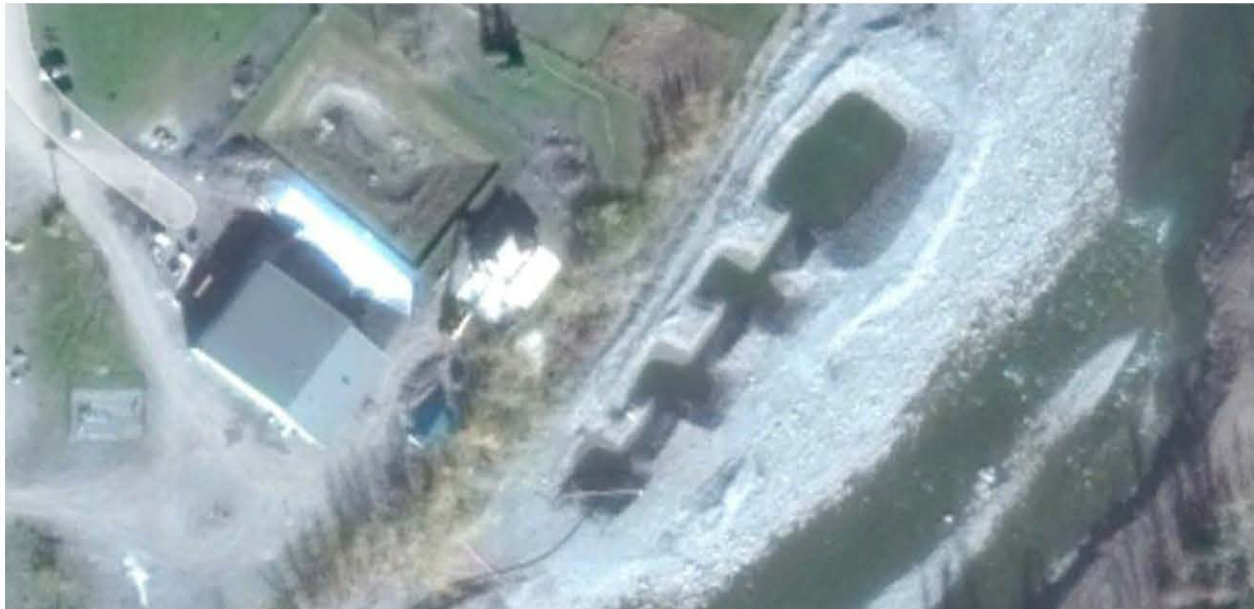
Figure 15: SRRUC's former infiltration pits on the Sheep River.

In the mid-2010s, and as an emergency measure, SRRUC had installed a series of temporary infiltration pits within the gravel and sand deposited on the left bank of the Sheep River immediately adjacent to the WTP (**Figure 15**). Water from the river infiltrated through the alluvial deposits and into the pits, where it was collected and pumped off to the water reservoir. It is understood that this set-up worked fairly well, though it required frequent maintenance.

The infiltration would act as a primary filtration process, allowing for some clarification of the river water, thus potentially allowing for operation during the turbid freshet months. Provided the pits were of a sufficient depth, winter operation is also likely.

The obvious drawback to using temporary infiltration pits is that the river will inundate this area during the mean annual flood, or possibly during lesser flood events (see **Figure B-2** in **Appendix B**). Inundation will result in infilling of the pits with debris and sediment and may altogether alter the topography of the left bank. These factors would result in additional maintenance requirements to maintain the pit structure.

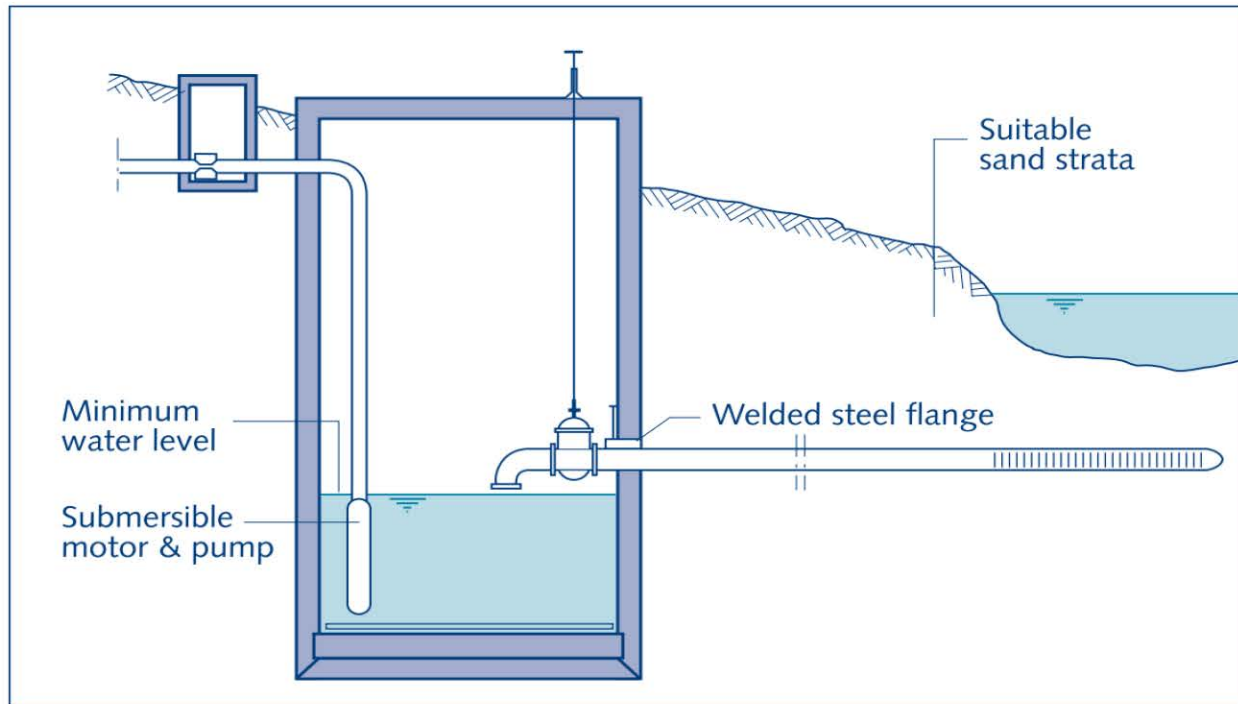
Figure 16: Direct Infiltration Intake schematic.

A direct infiltration intake is a subsurface water intake structure designed to collect water from a river, lake, or groundwater through a natural filtration process. It consists of a network of perforated pipes or conduits buried in a gravel and sand bedding beneath the water source (Fetter, 2001). The bedding provides for a progressively finer filtration media that helps to remove particulate, organics and other materials prior to diversion through the intake pipes, thereby improving water quality delivered to a treatment plant. Being buried below the riverbed, this type of water intake has a minimal surface expression, which helps to protect the intake pipes and mitigates entrainment of fish and aquatic organisms.

However, experience with direct infiltration intakes in Alberta rivers is mixed, specifically when deployed in rivers with high sediment loadings. As the concept relies on infiltration, finer sediments are removed in the filtration media. This results in clogging of the filtration media, which requires either media backflush using air or water, mechanical agitation (e.g. with an excavator) or complete replacement of filtration media. None of these maintenance activities are particularly straight-forward. Further, in rivers that are highly active, changes in channel alignment may re-route a river away from the filtration media resulting in an off-channel system that may not function as effectively as one directly below a watercourse. However, the above issues can be attenuated by oversizing the systems.

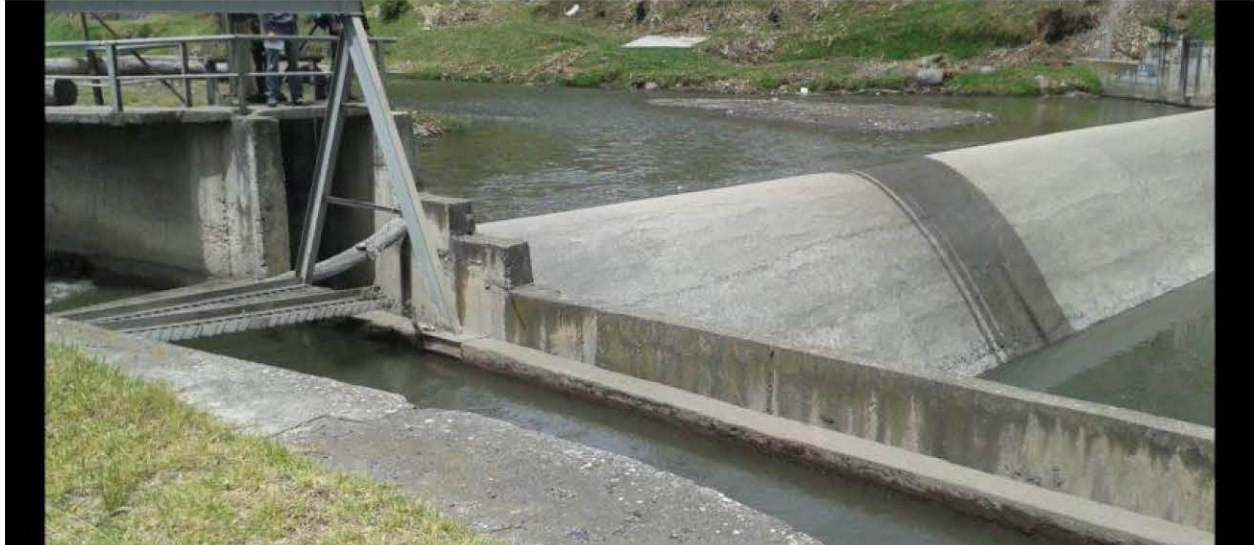
Figure 17: Example of a lateral water intake behind a diversion weir.

The operation and maintenance of a lateral water intake involves regular cleaning of intake screens, inspection and removal of debris, and occasional removal of sediment accumulation within the forebay.

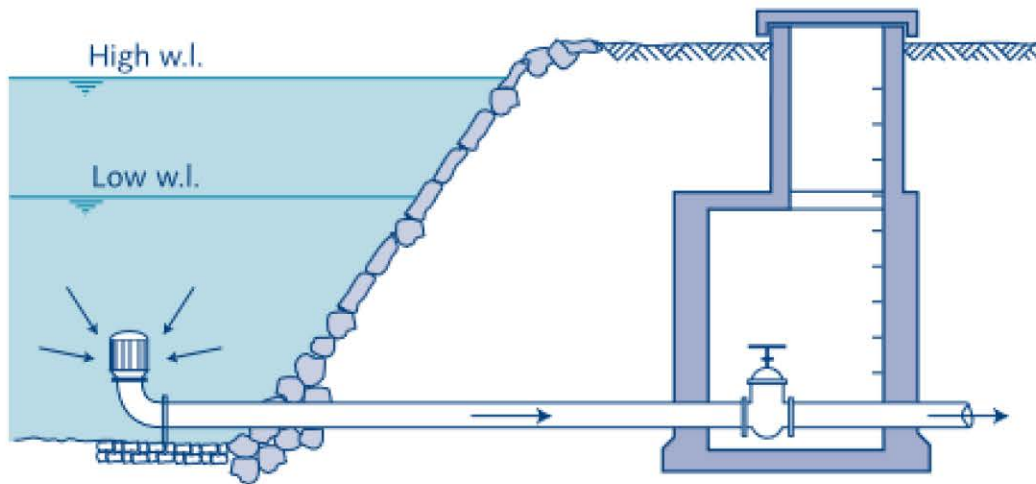
Figure 18: Schematic of a submerged intake screen.

The operation of submerged screen intakes requires routine maintenance to avoid blockages caused by sediment buildup, debris, or aquatic growth. Regular inspections and cleaning are essential to maintain efficient flow and prevent clogging, which can reduce water intake performance.

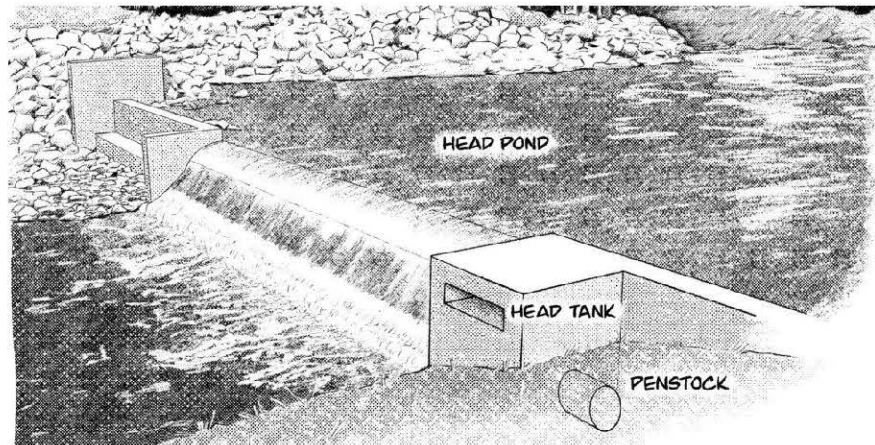
Figure 19: Schematic of a Coanda water intake.

For a Coanda screen to function properly, the water surface must be raised behind a low diversion weir to form a small head pond. This pond has two main purposes: first, it helps to facilitate proper flow conditions over the Coanda screen to ensure maximum performance; second, it acts as a sediment trap, which is primarily to minimize wear of the screen wires. A flushing (sluice) gate is often incorporated into the diversion weir design to regulate water levels and flush sediments from the headpond.

reduces performance, thereby necessitating effective sediment management protocols. Also, tree leaves and needles can clog or blind screen openings if not effectively managed.

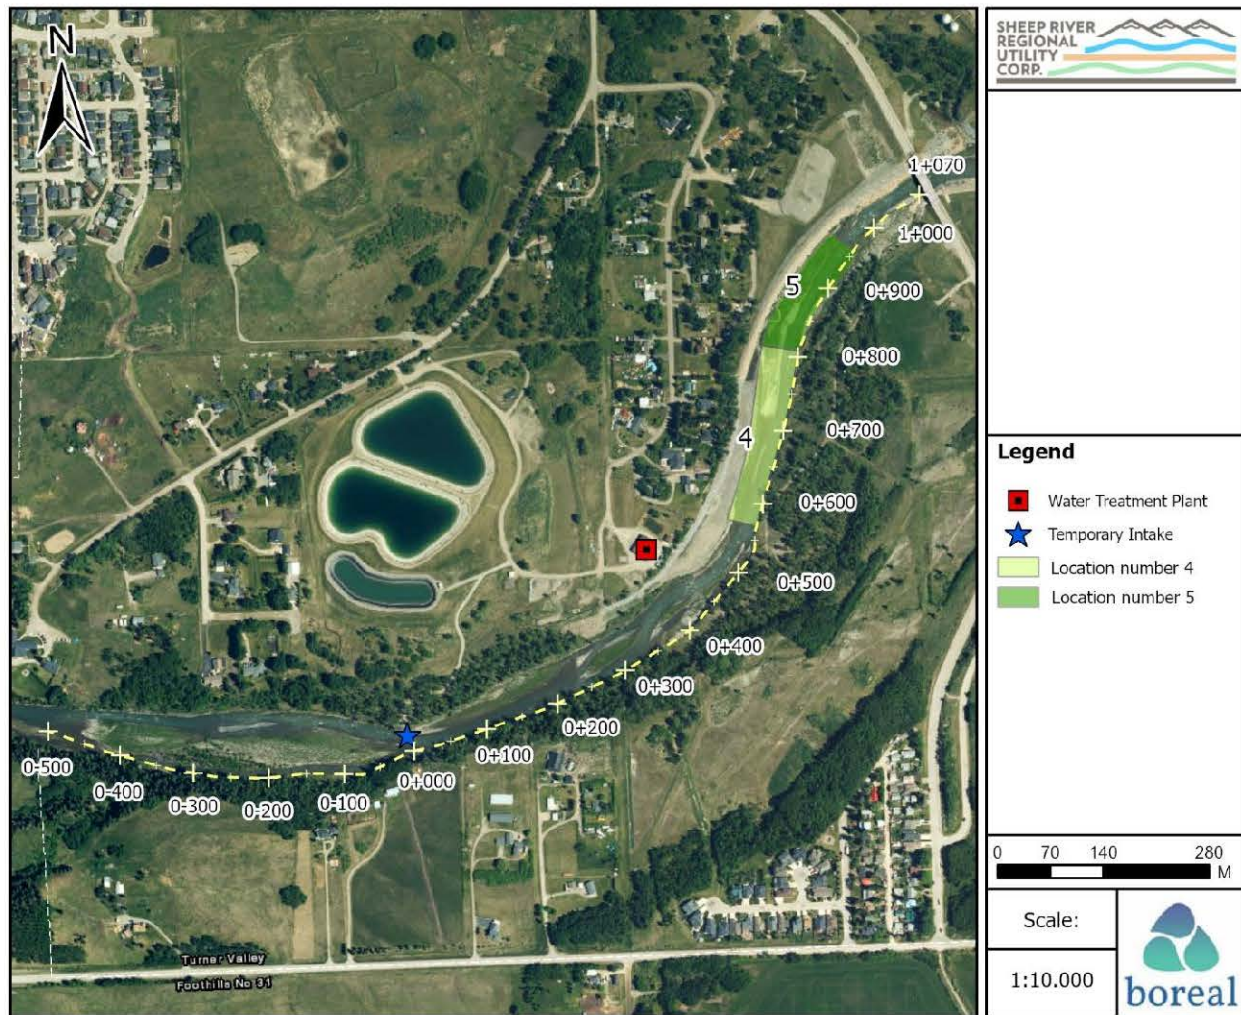
Figure 20: Selected reaches for a potential direct infiltration intake.

According to the analysis in the **Table 9**, the best location for the installation of a direct infiltration intake appears to be Location #5, followed by the Location #4. This location provides the most appropriate combination of features, such as river hydraulics, geomorphological conditions, sediment behavior, and terrain advantages.
