Sheep River Intake Feasibility Assessment

Final Revision 0

Project No. 142001

Boreal Water Resources Ltd.
201 – 11 Fairway Drive N.W.
Edmonton, AB T6J 2W4

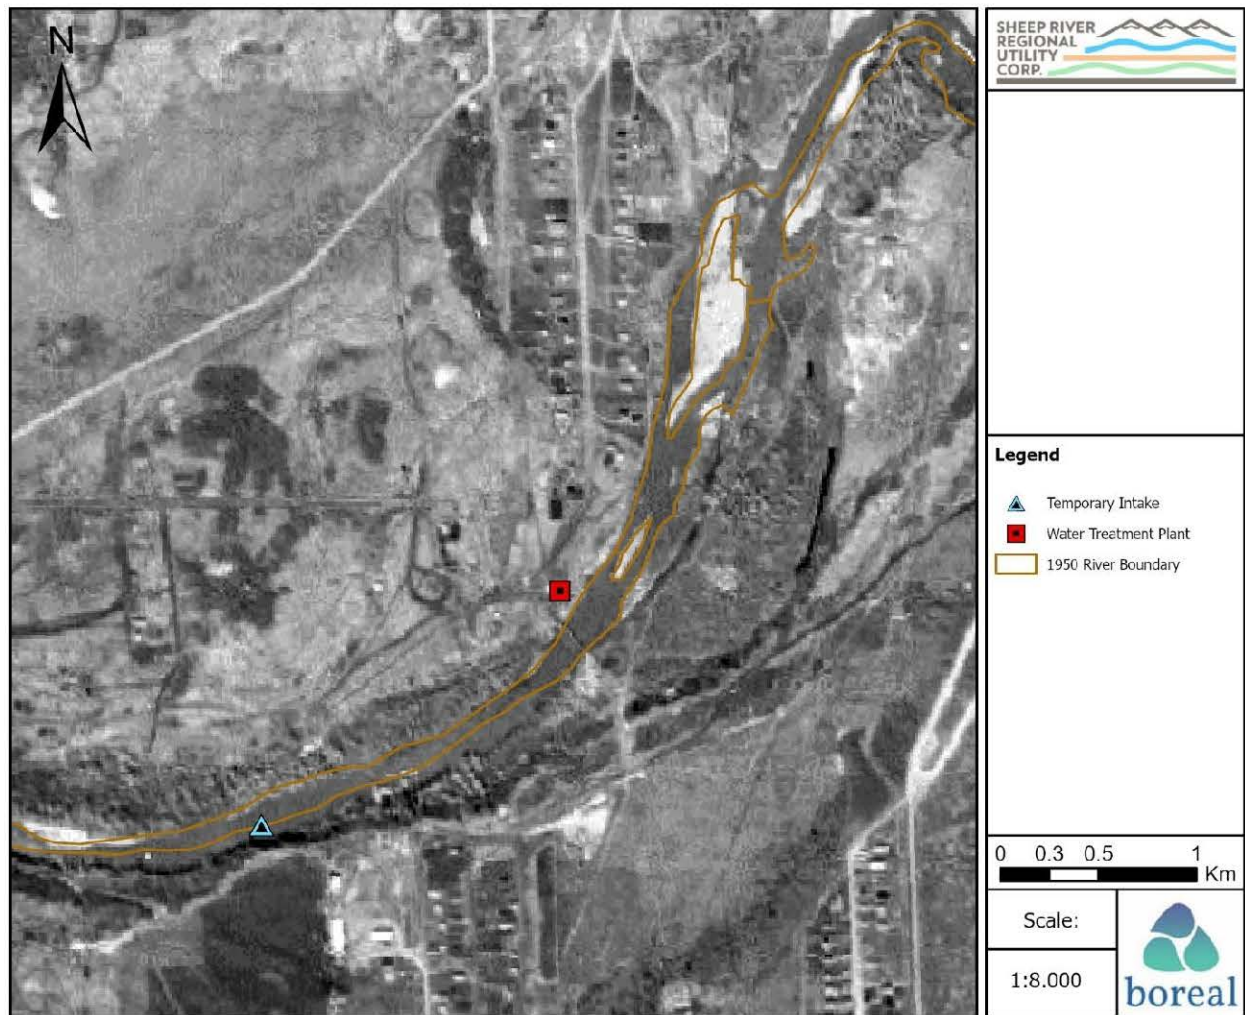
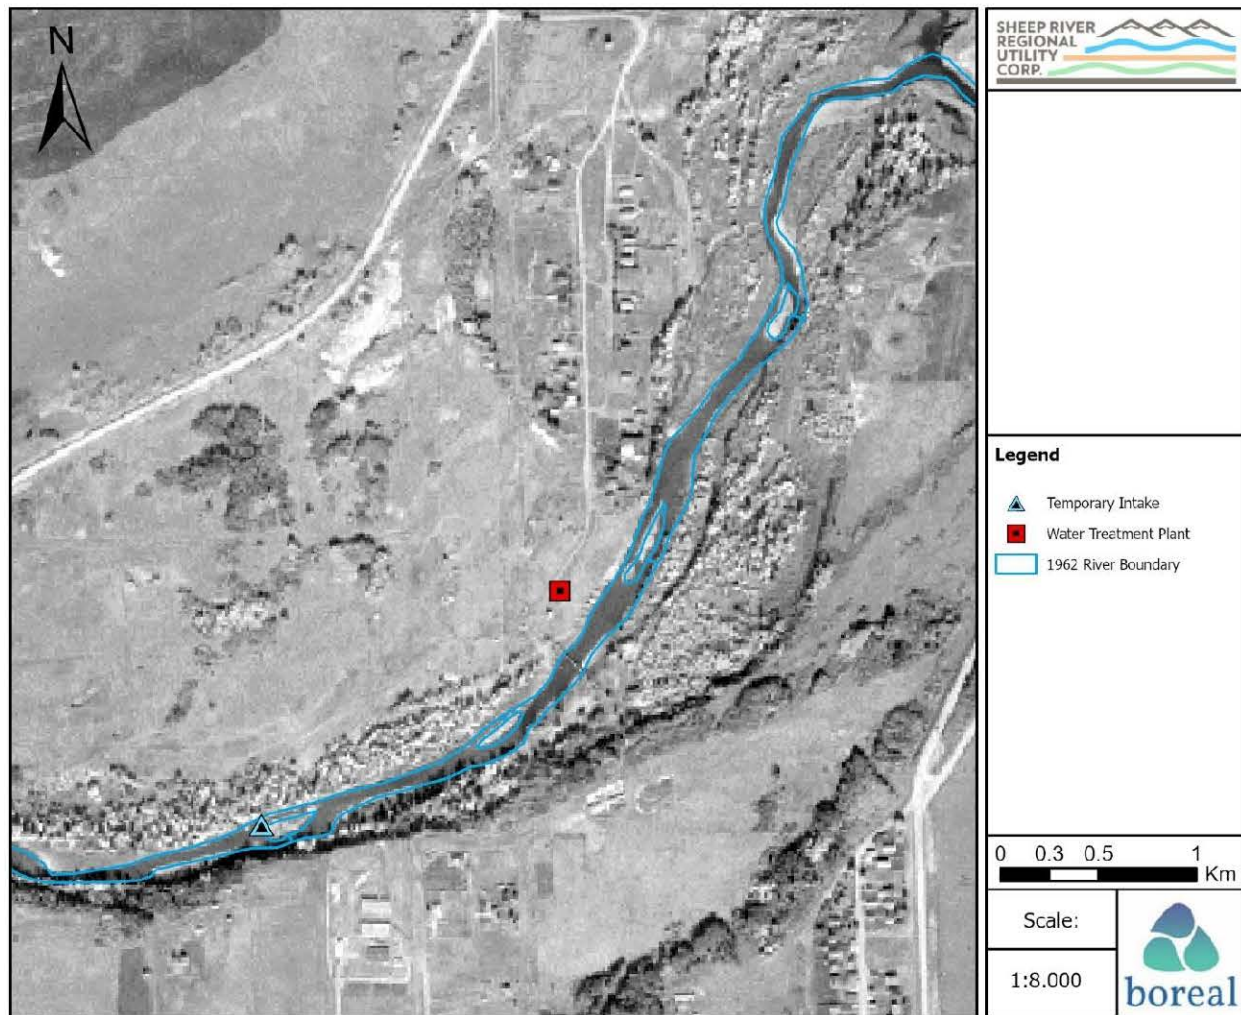
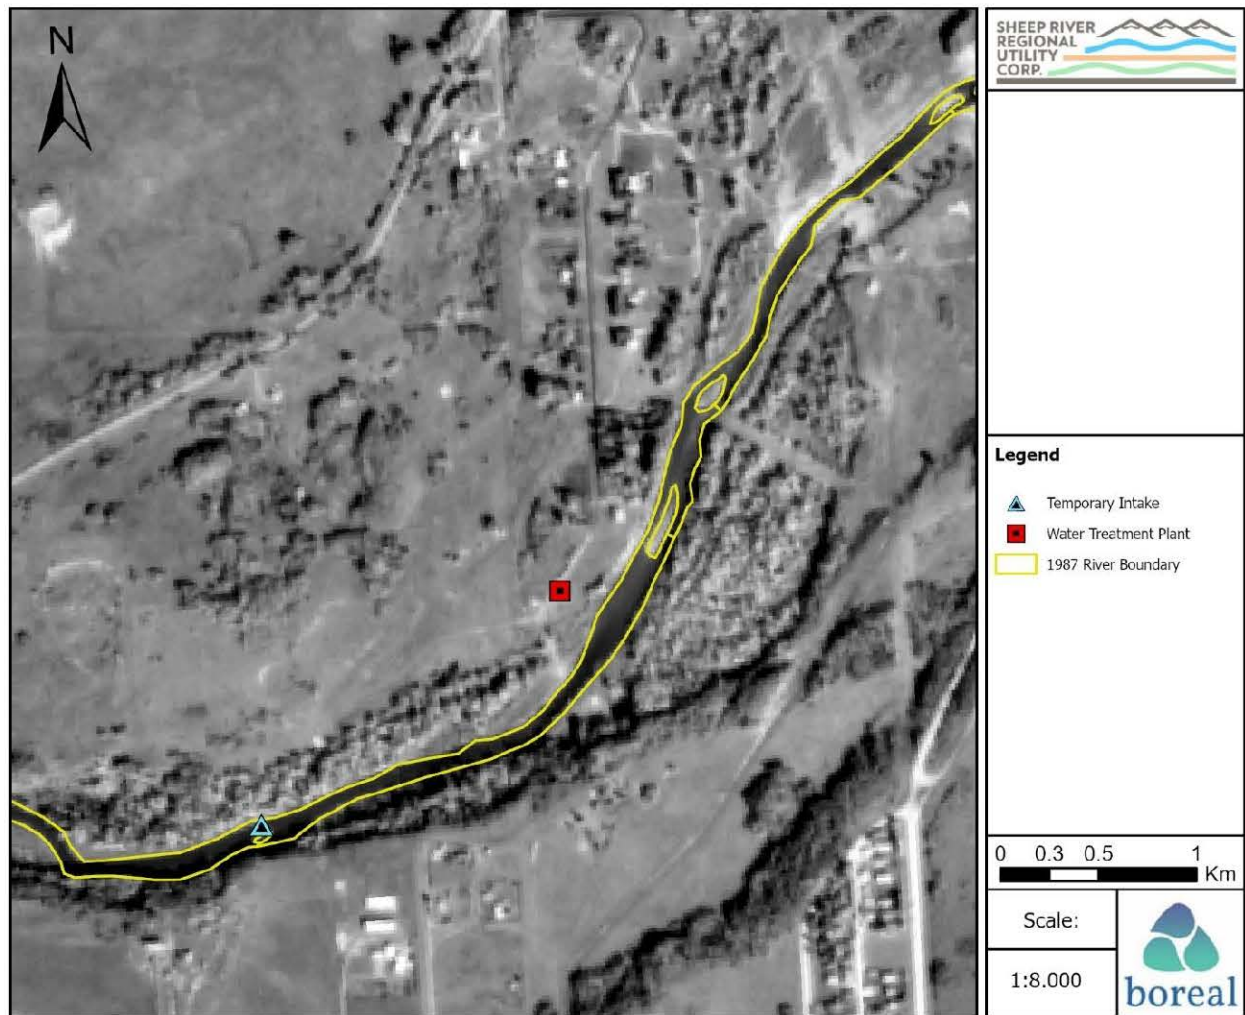
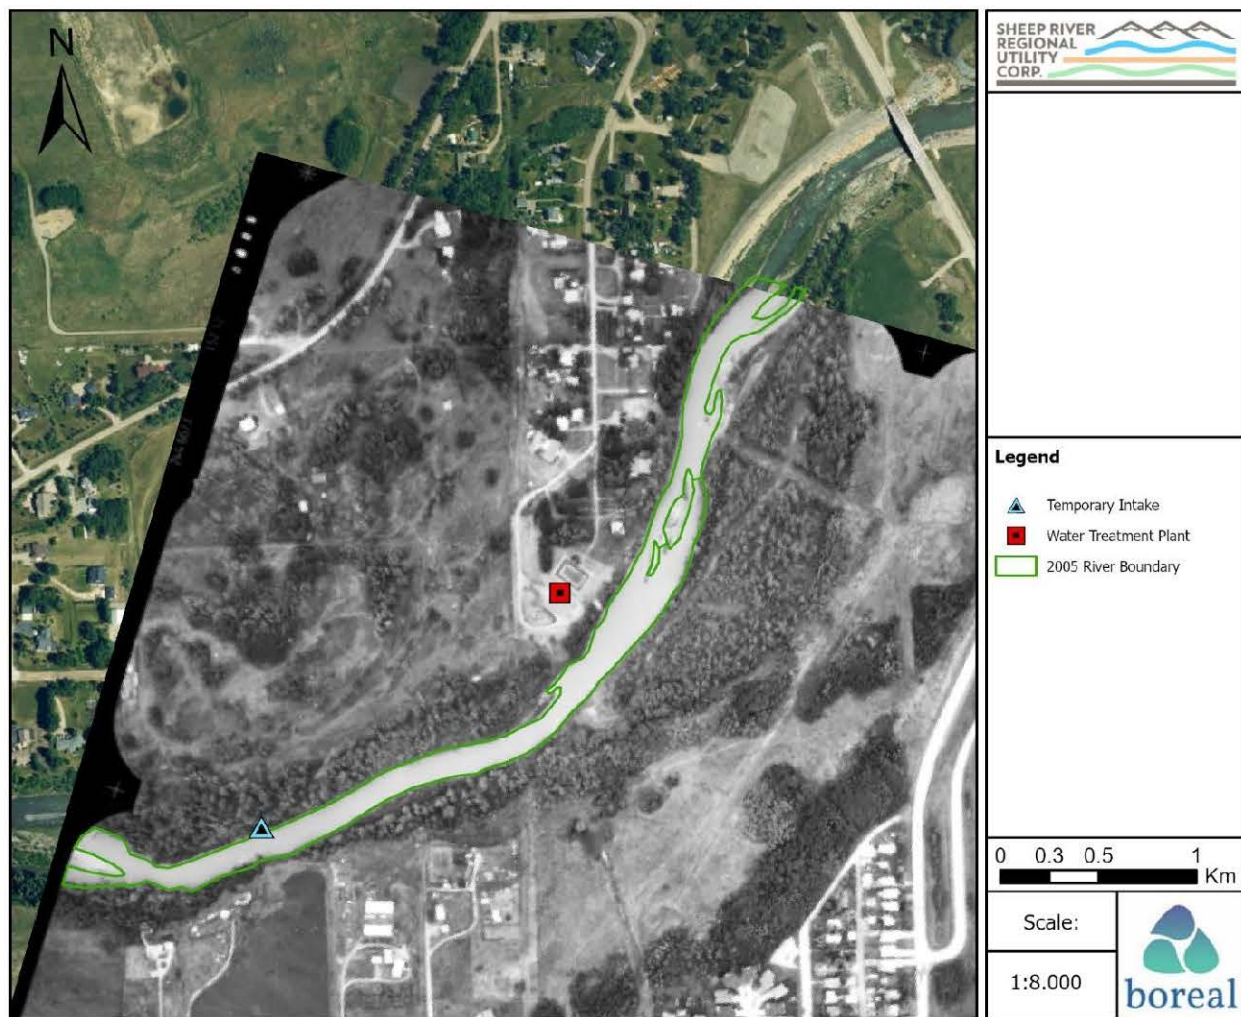
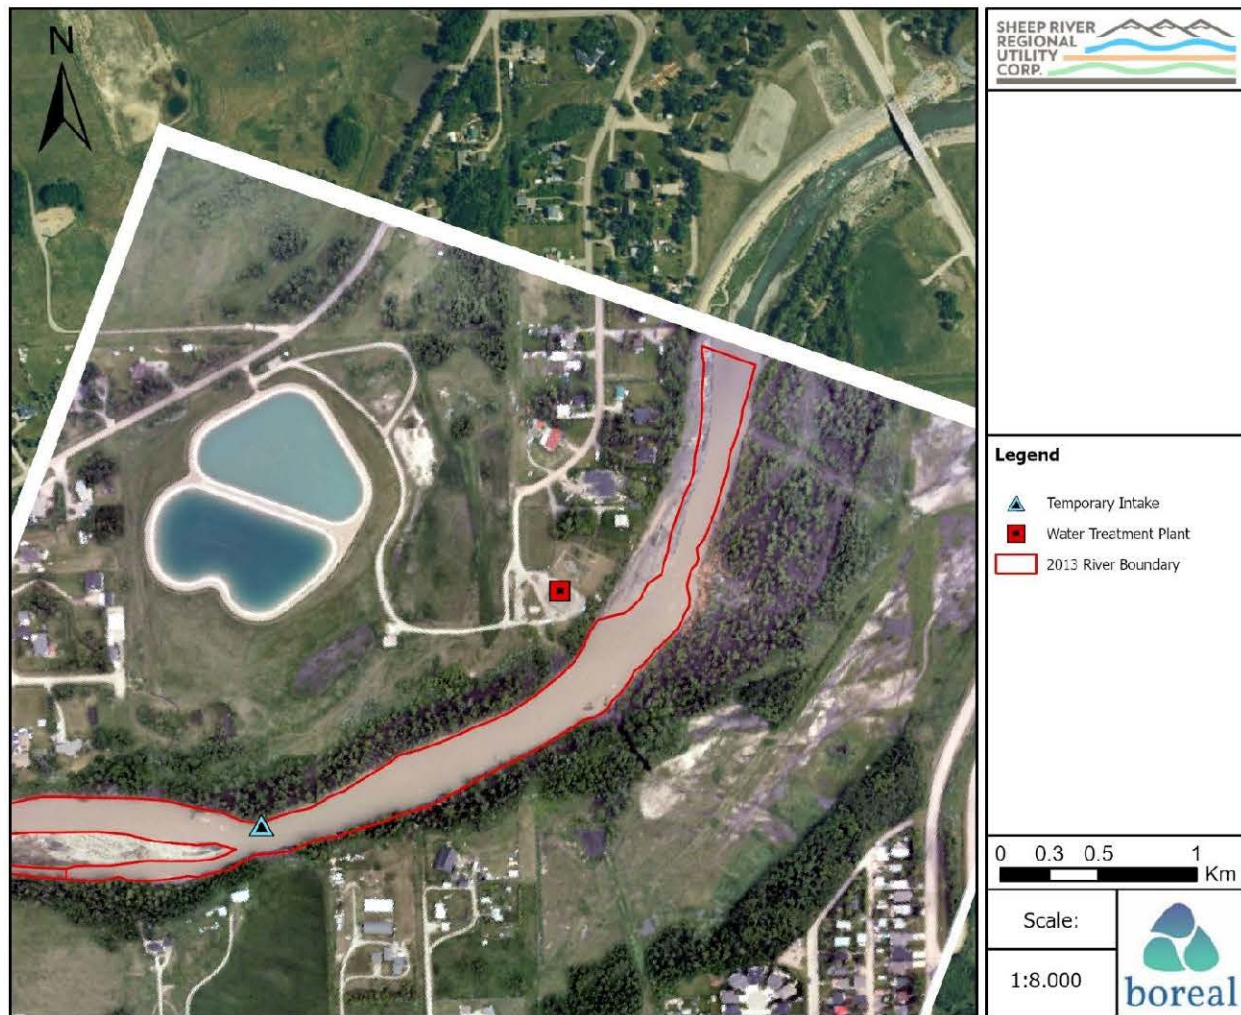
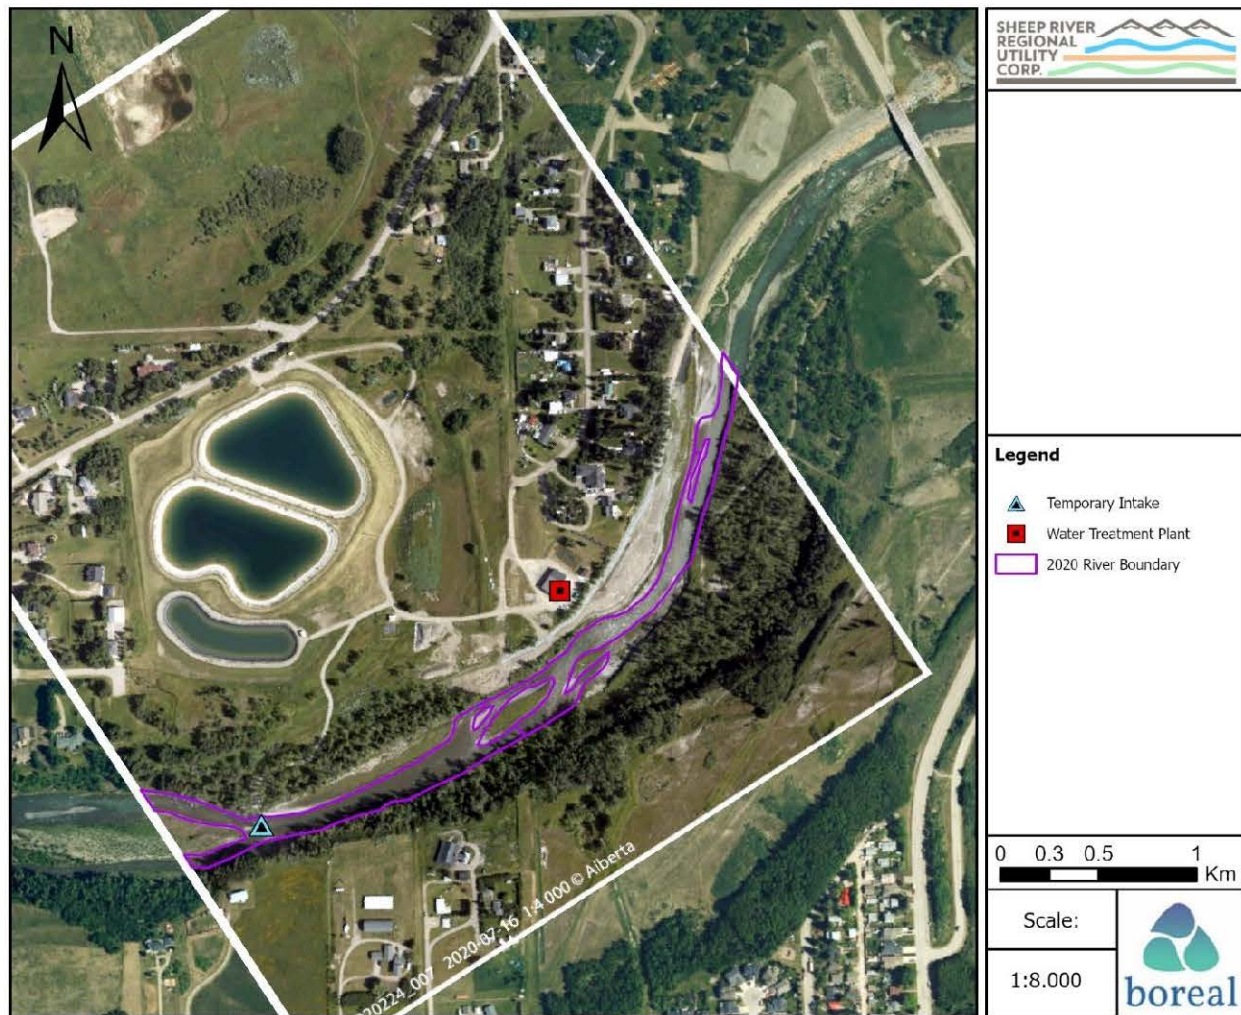
Figure A-1: Channel alignment in 1950.

Figure A-2: Channel alignment in 1962.

Figure A-3: Channel alignment in 1987.

Figure A-4: Channel alignment in 2005.

Figure A-5: Channel alignment in 2013.

Figure A-6: Channel alignment in 2020.

A multitemporal analysis was performed with aerial images from 1950 through 2020. These images reveal the high dynamism of this reach. The observed behavior of the reach aligns with its classification, as highly dynamic environments are common for wandering rivers in foothill regions (see **Figure 8**). **Appendix A** provides more detail each year with the corresponding aerial imagery.

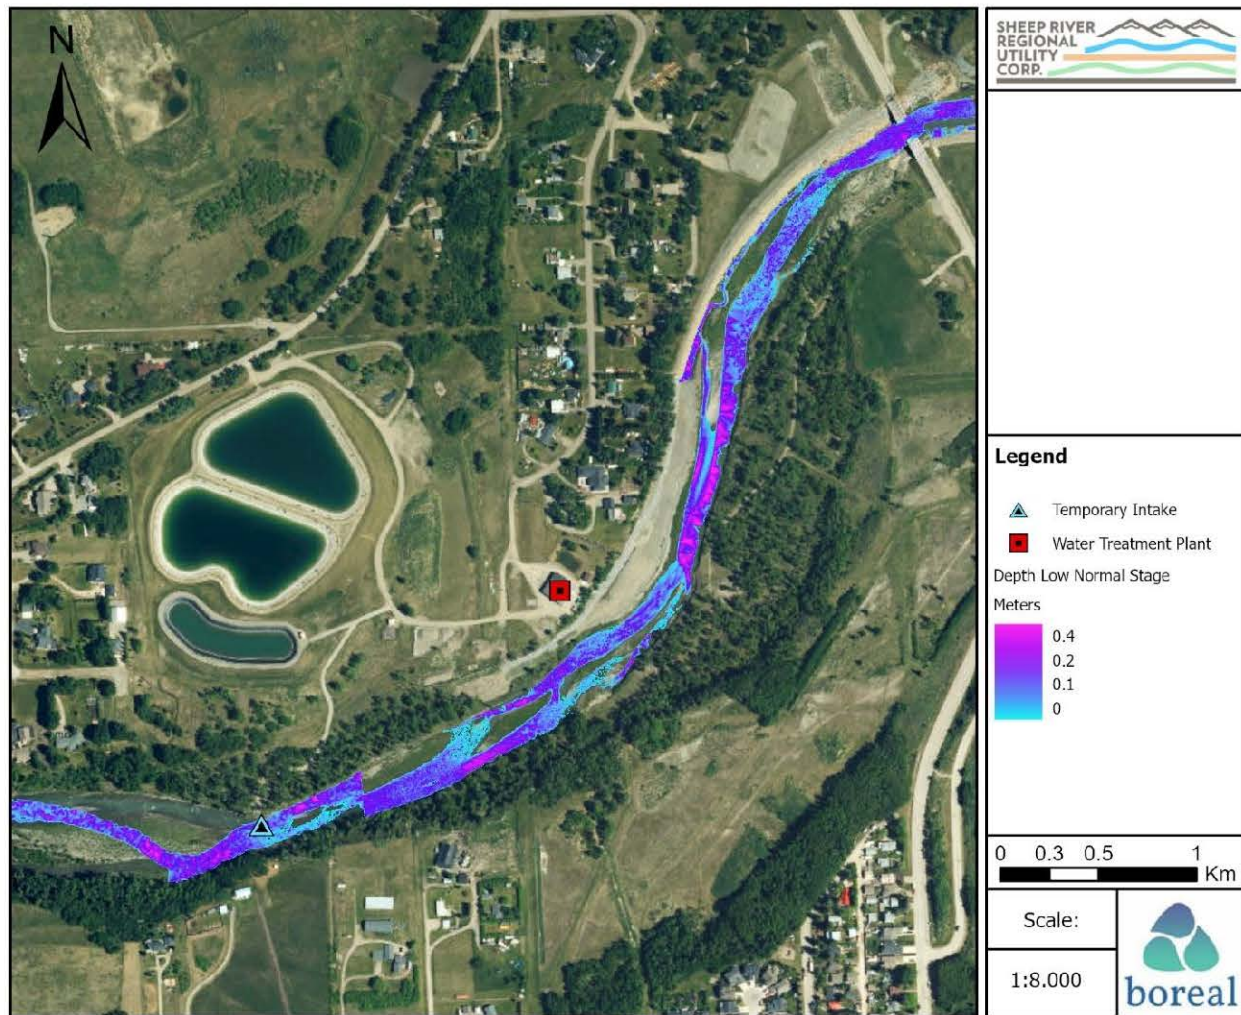
Figure B-1: Low-flow hydrodynamic model results, depth – Q_{95} ($0.65 \text{ m}^3/\text{s}$).

The results from the normal low-stage analysis indicate relatively shallow depths throughout most of the reach (0.4 m or less), as shown in **Appendix B (Figure B-1)**. Velocities of approximately 0.25 m/s are observed in throughout much of the Study Reach (**Figure B-5**) indicating a strong likelihood of sediment deposition. The exception to this is in the straight, narrow, non-braided reaches where velocities increase and in the riffle segments where the velocities can reach 1.0 m/s. This corroborates the findings of the geomorphic assessment that finer materials are less likely to accumulate in these areas. This latter feature would be beneficial in the context of a direct infiltration intake, where fines have a tendency to clog the interstices of the filtration media.

The shallow depths, high velocities in high flow/stage conditions, and wetted surface area shown in **Figure B-1** and **Figure B-5** also highlight the vulnerability of fixed points of diversion (e.g., submerged screen, side intake) to changing river conditions. The wetted surface area is dependent on the present-day channel alignment. This suggests that a modest scour event, as may occur during a flooding event, raises the risk that a fixed point of diversion becomes stranded outside of the wetted surface area. Further, the shallow depths effectively limit permanent intake options to direct infiltration intakes or bottom intakes. To mitigate against these two issues within the Study Reach would require that a diversion weir and head pond (small reservoir) be created.

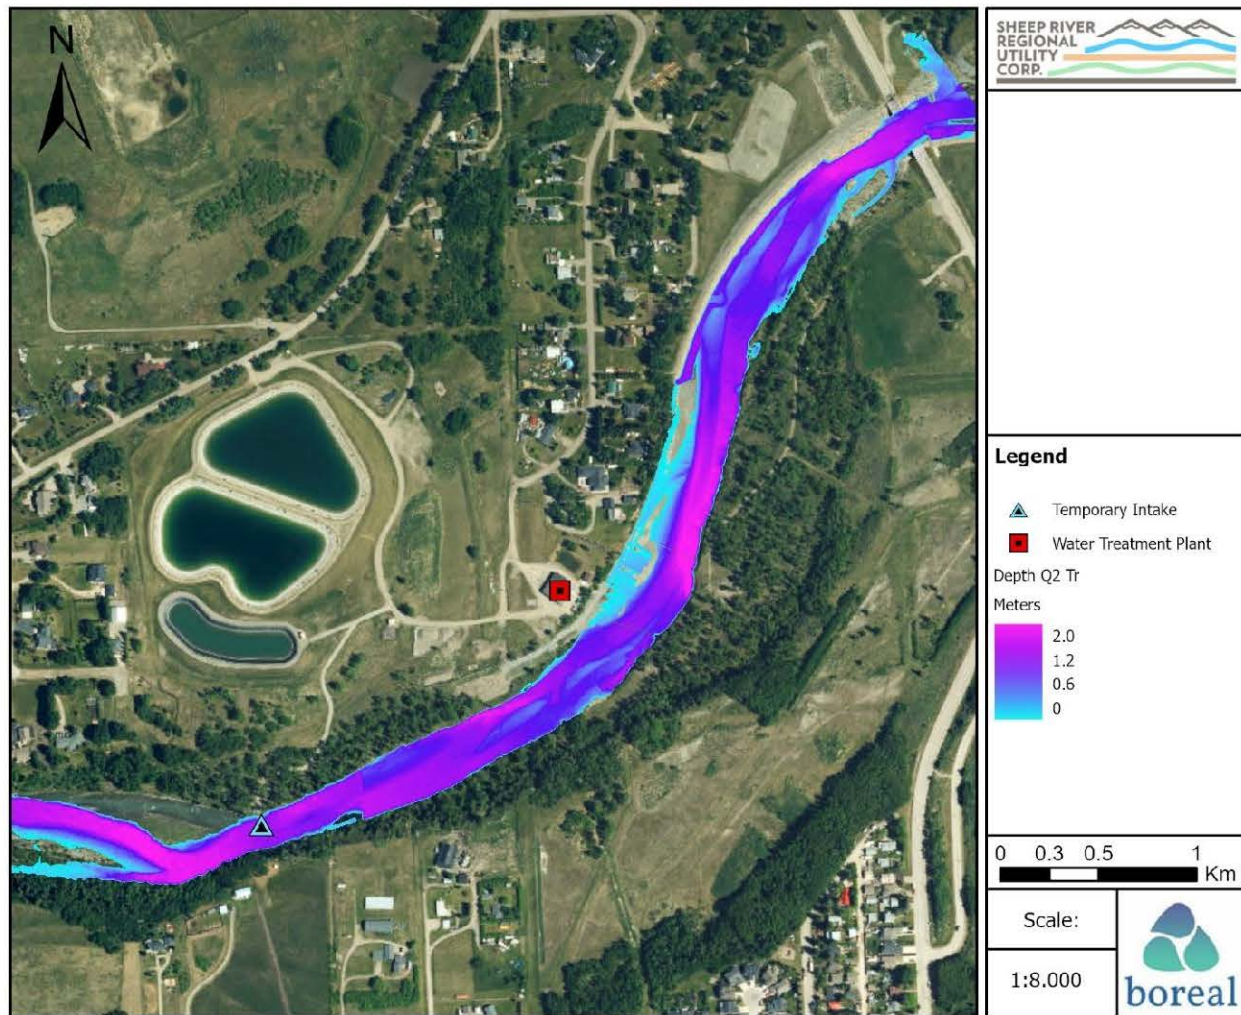
Figure B-2: Peak flow hydrodynamic model results, depth – Q_2 ($92 \text{ m}^3/\text{s}$).

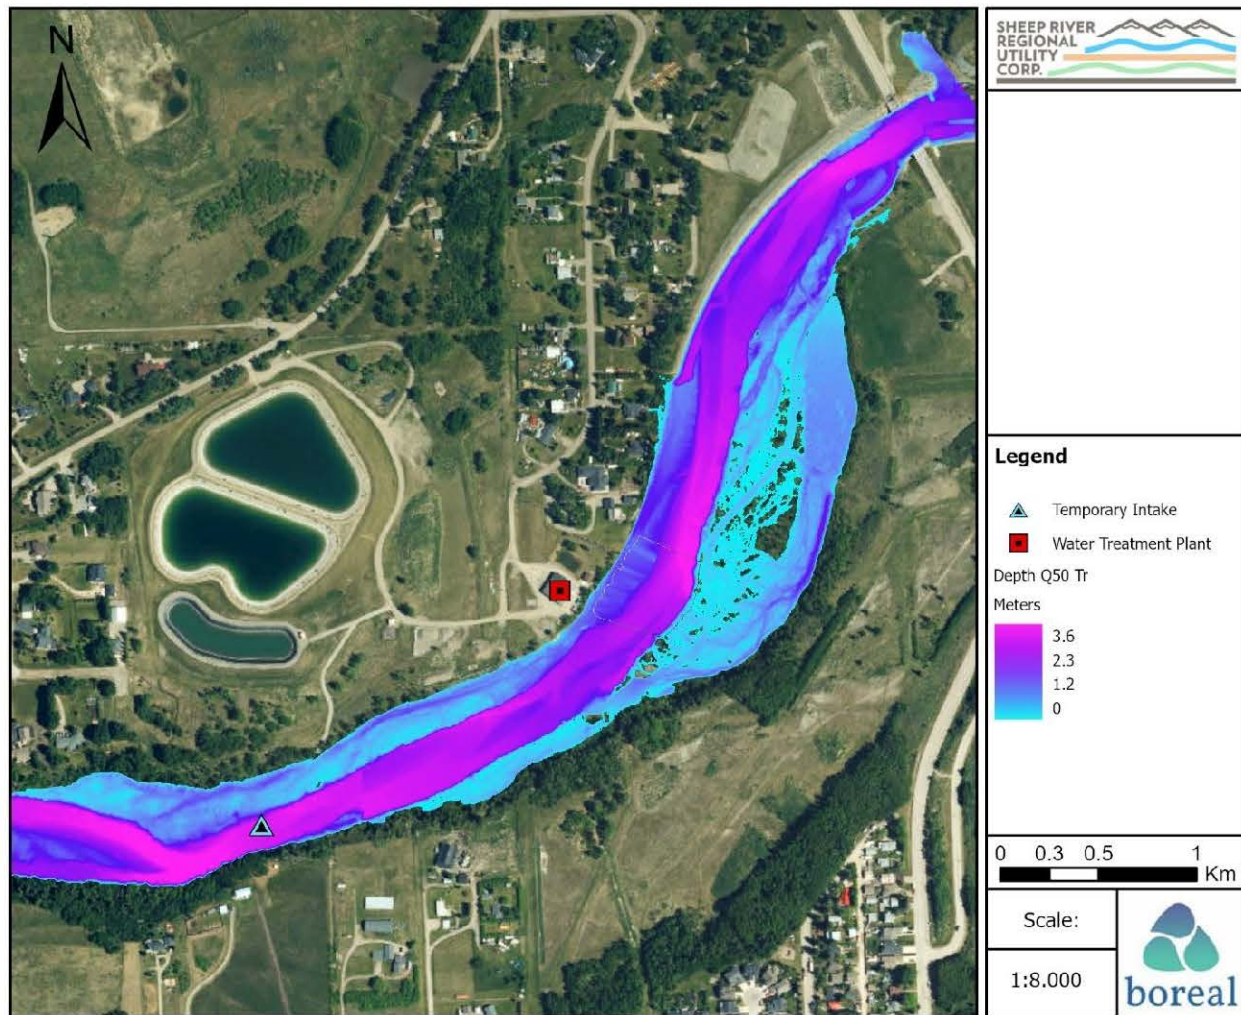
Figure B-3: Peak flow hydrodynamic model results, depth – Q_{50} (462 m³/s).

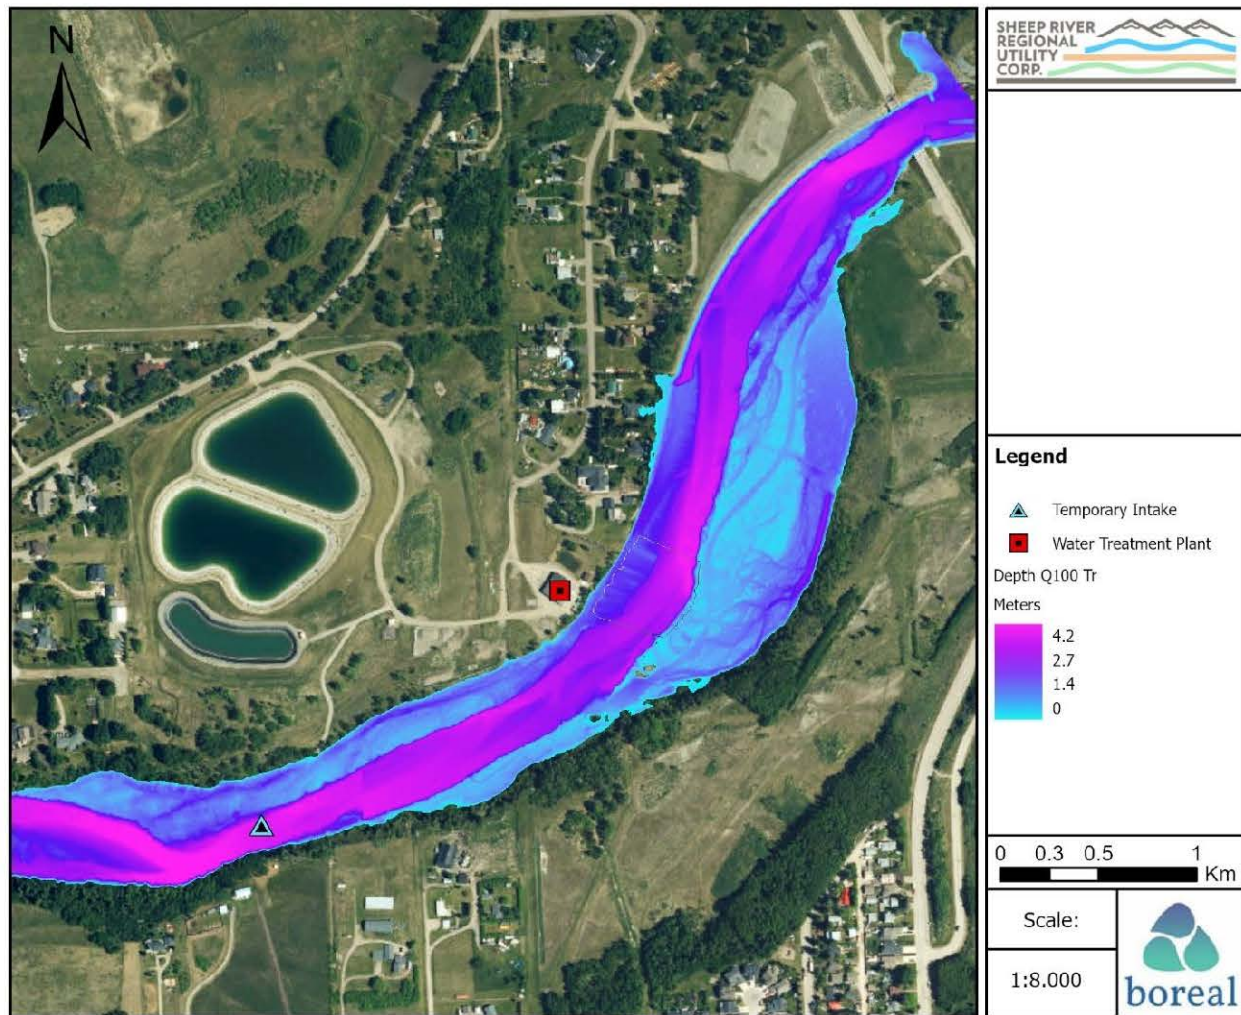
Figure B-4: Peak flow hydrodynamic model results, depth – Q_{100} (669 m³/s).

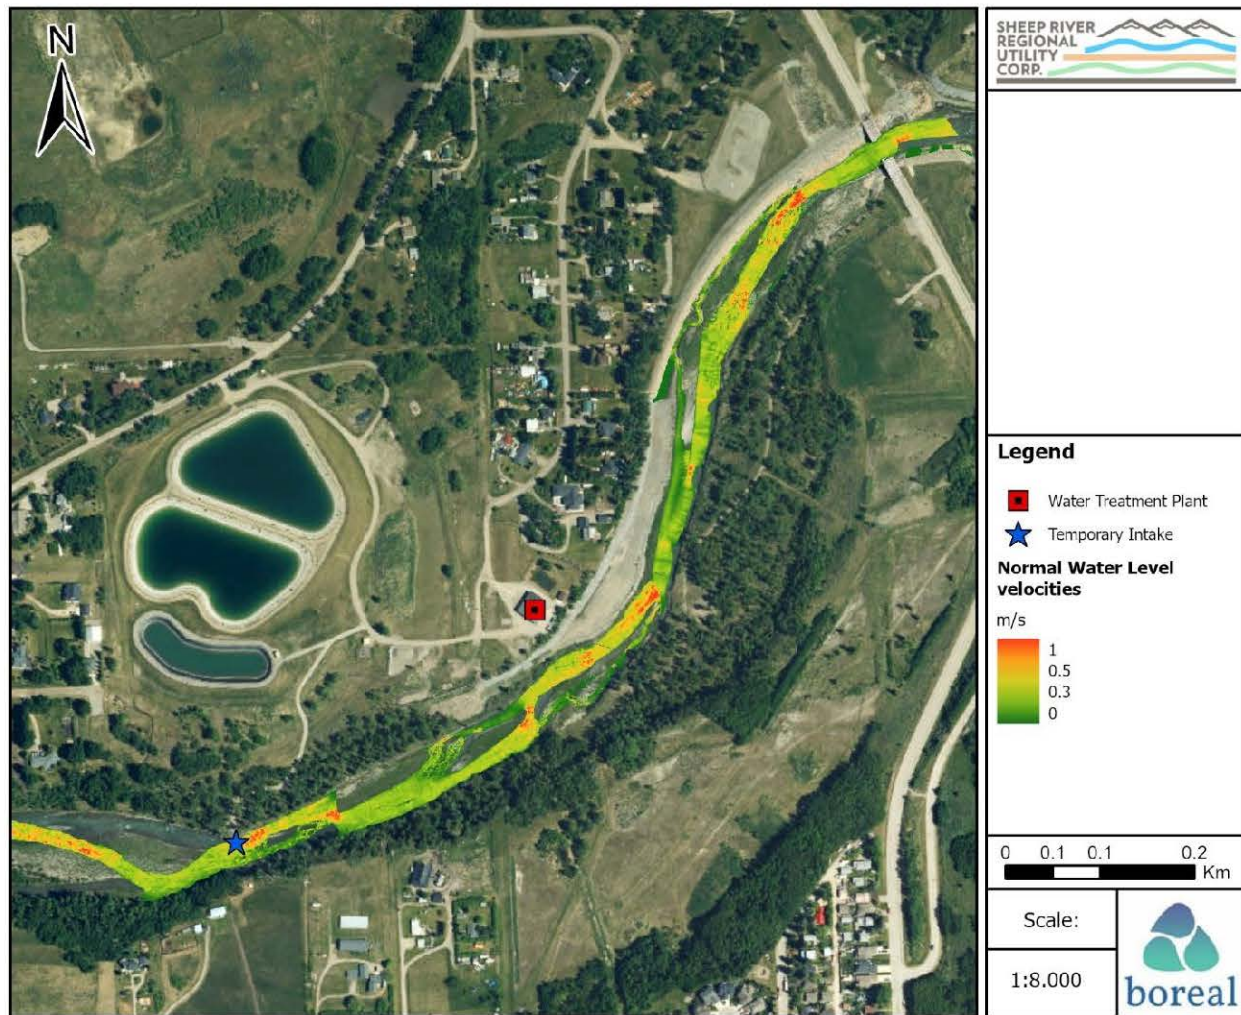
Figure B-5: Low-flow hydrodynamic model results, velocity – Q_{95} ($0.65 \text{ m}^3/\text{s}$).

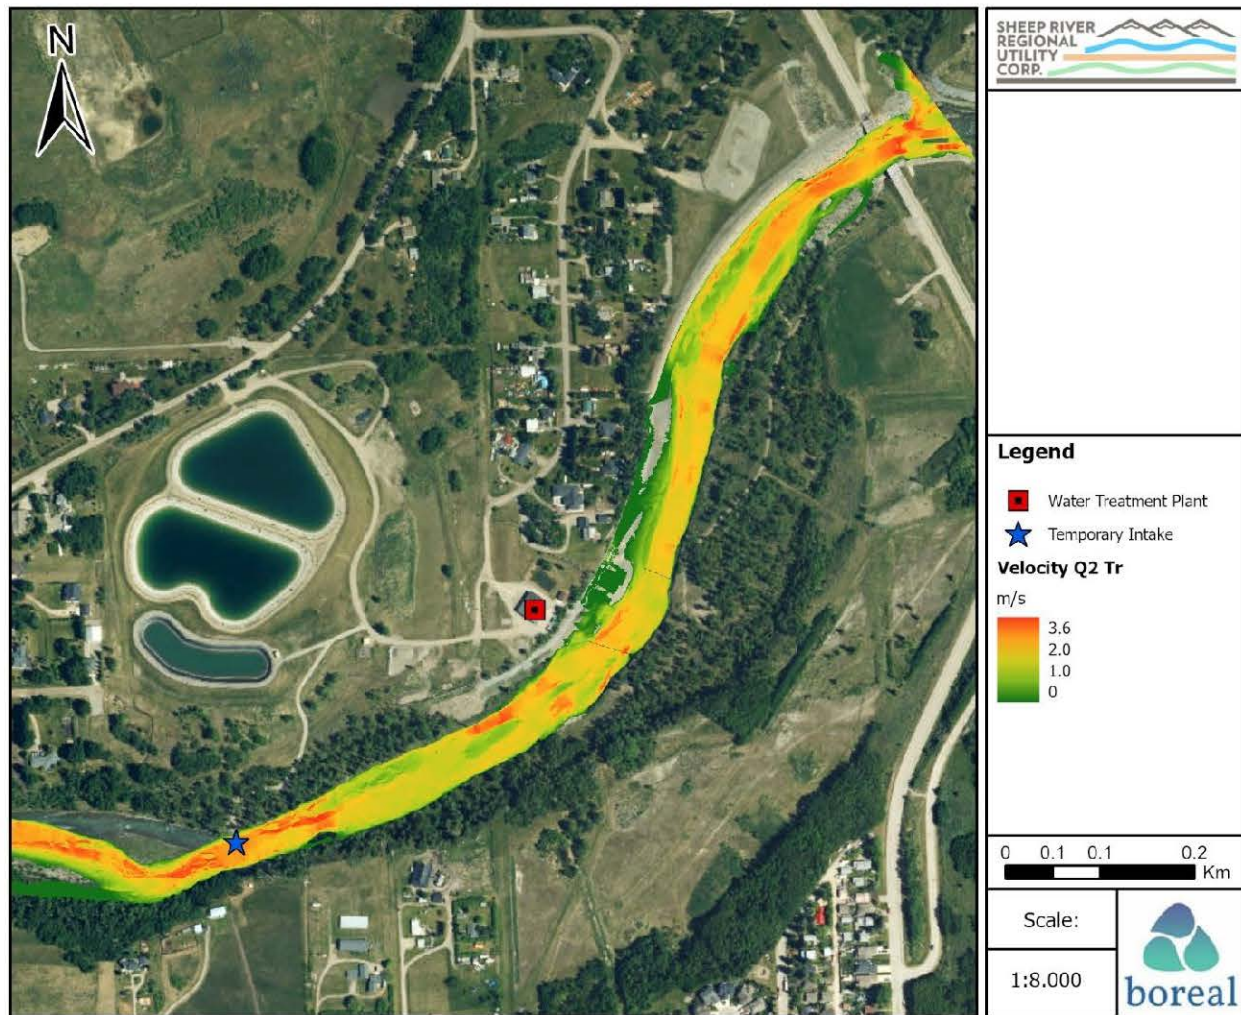
Figure B-6: Peak flow hydrodynamic model results, velocity – Q_2 (92 m³/s).

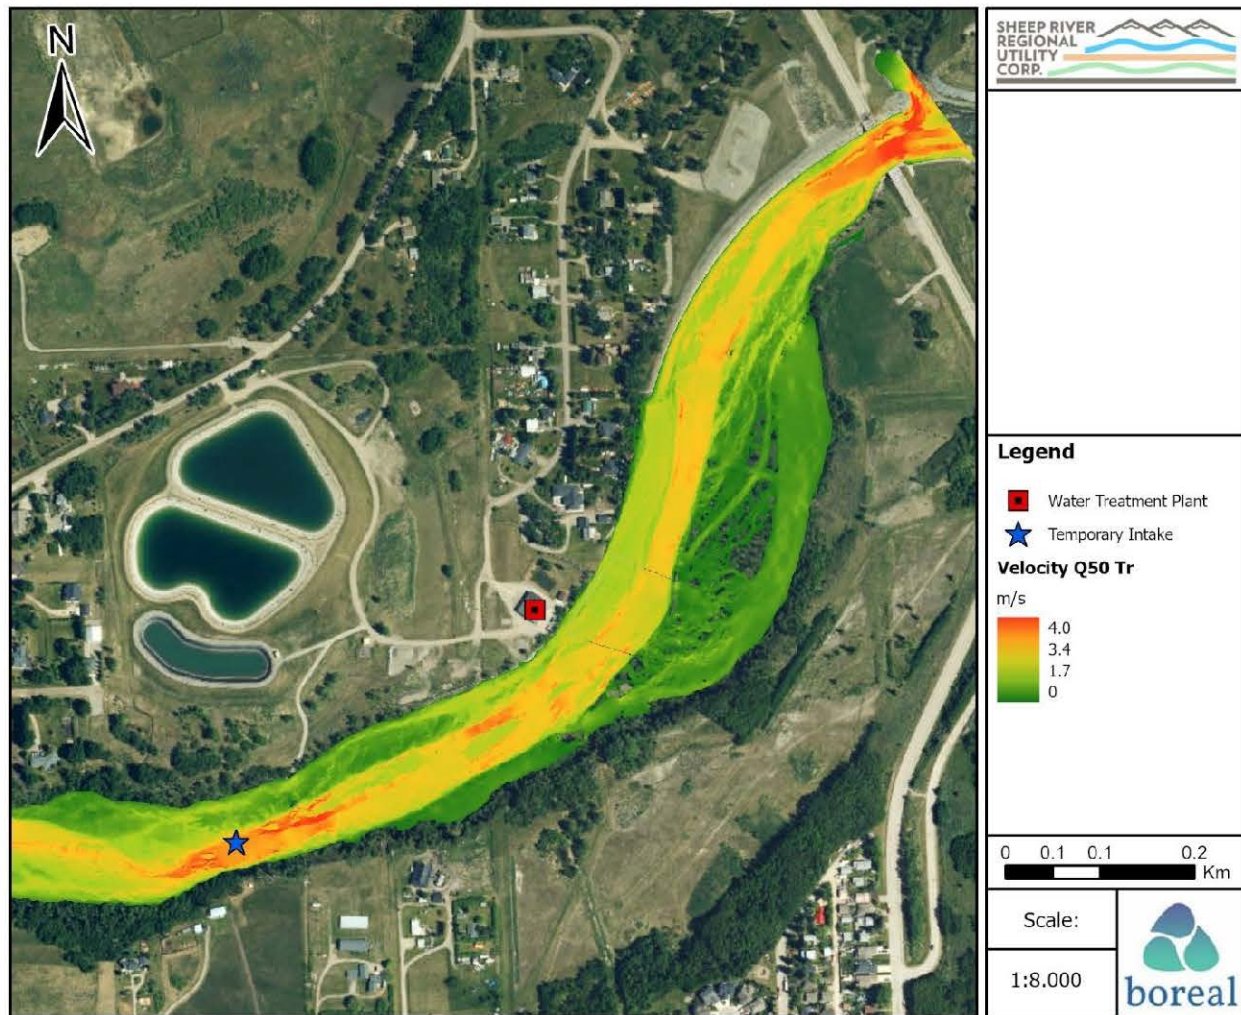
Figure B-7: Peak flow hydrodynamic model results, velocity – Q_{50} (462 m³/s).

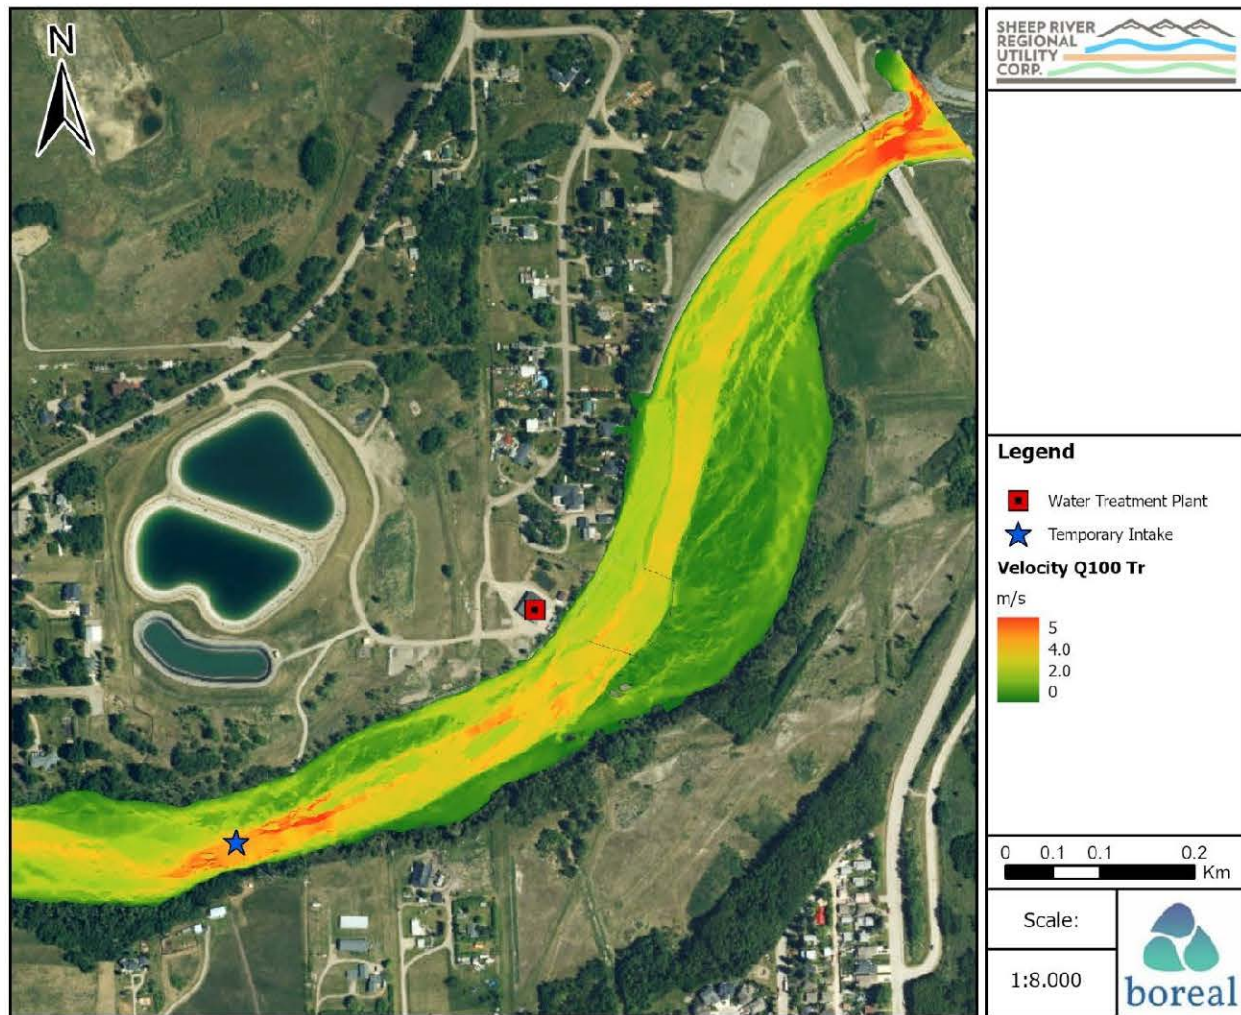
Figure B-8: Peak flow hydrodynamic model results, velocity – Q_{100} (669 m^3/s).

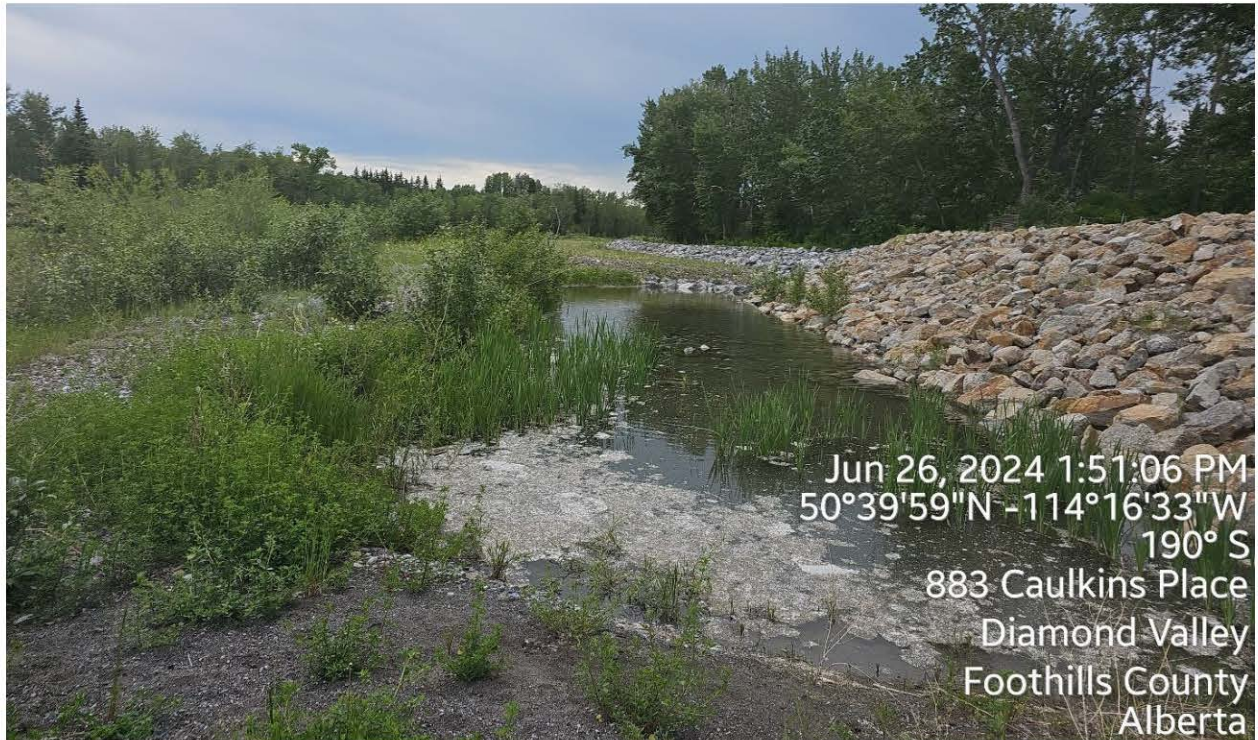
Figure C-3: Flood protection berm at the left side of the Sheep River floodplain.

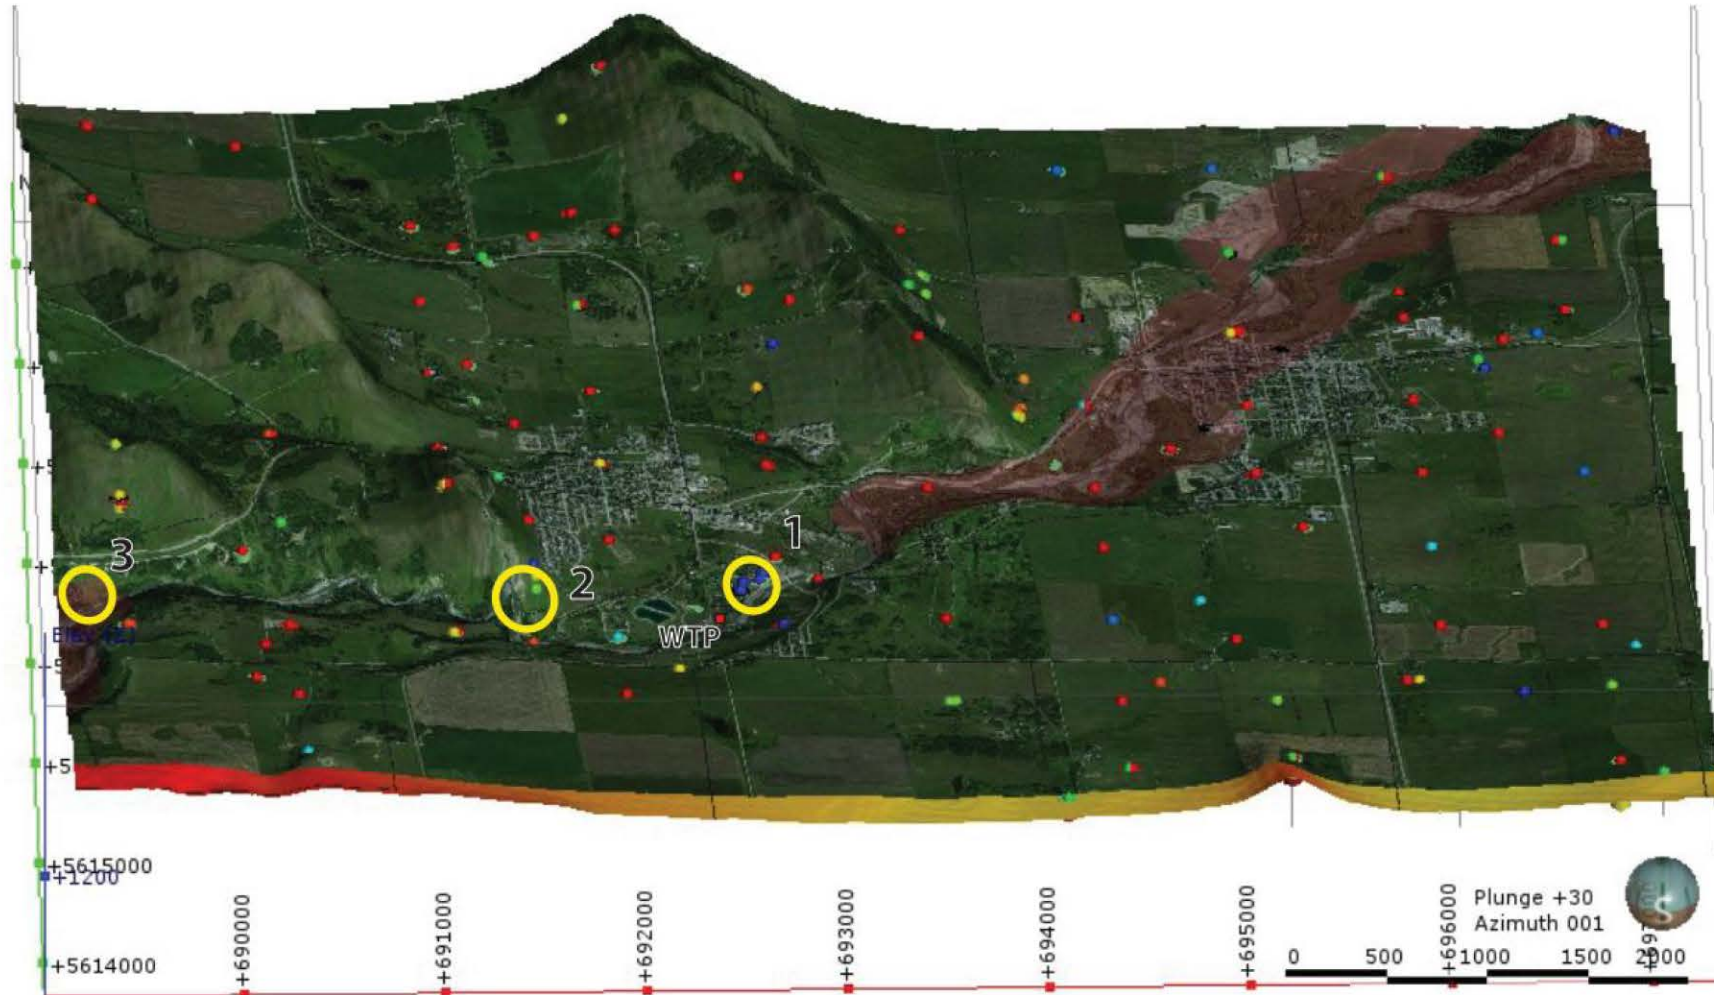
Figure D-1: 3D Geological model domain areas of potential productive aquifer targets (Stantec, 2016).

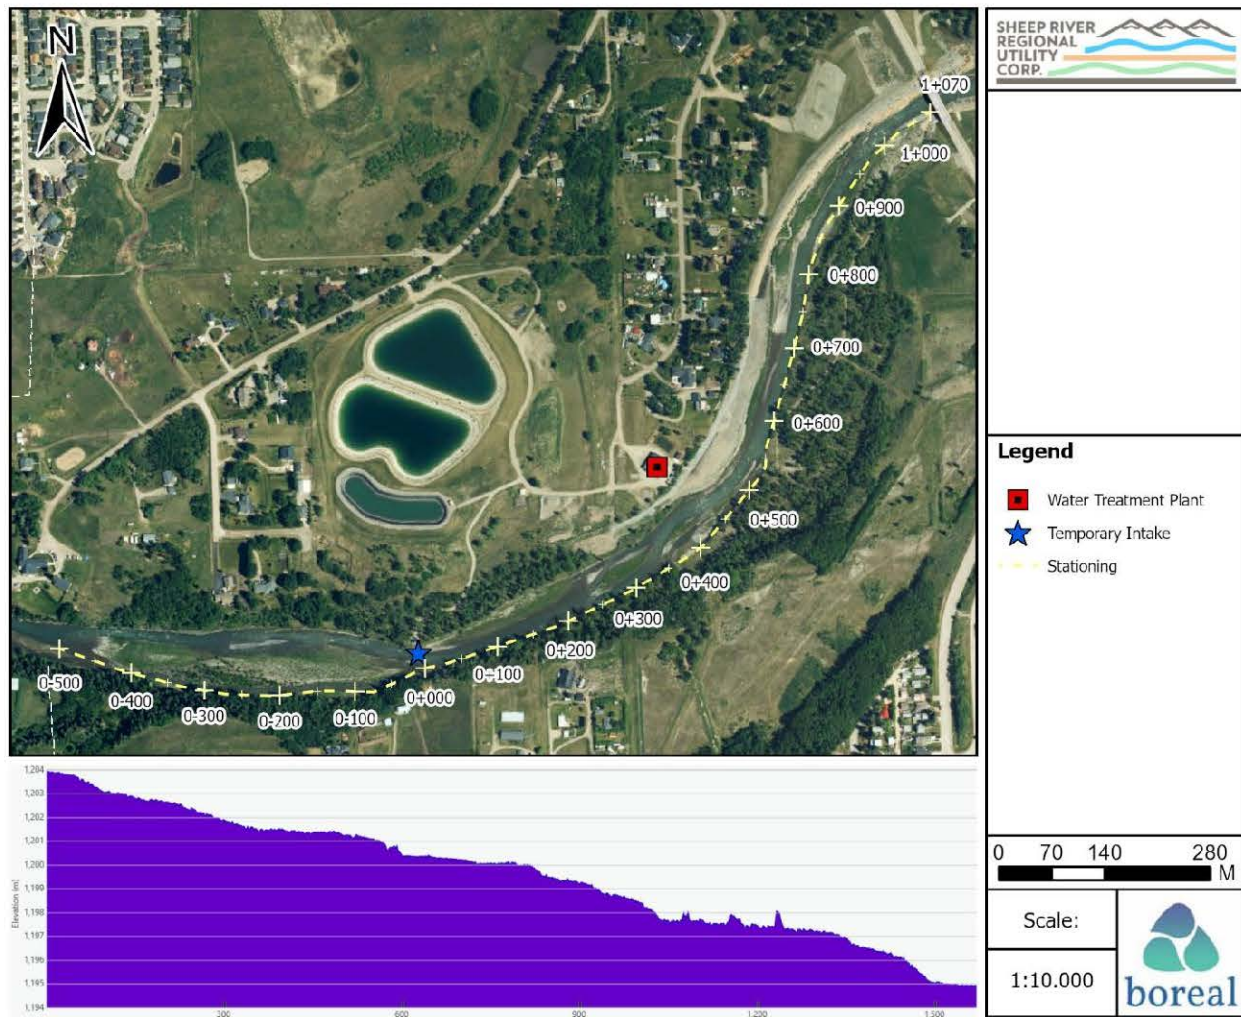
Figure E-1: Reach elevation profile.
