Sheep River Intake Feasibility Assessment

Final Revision 0

Project No. 142001

Boreal Water Resources Ltd.
201 – 11 Fairway Drive N.W.
Edmonton, AB T6J 2W4

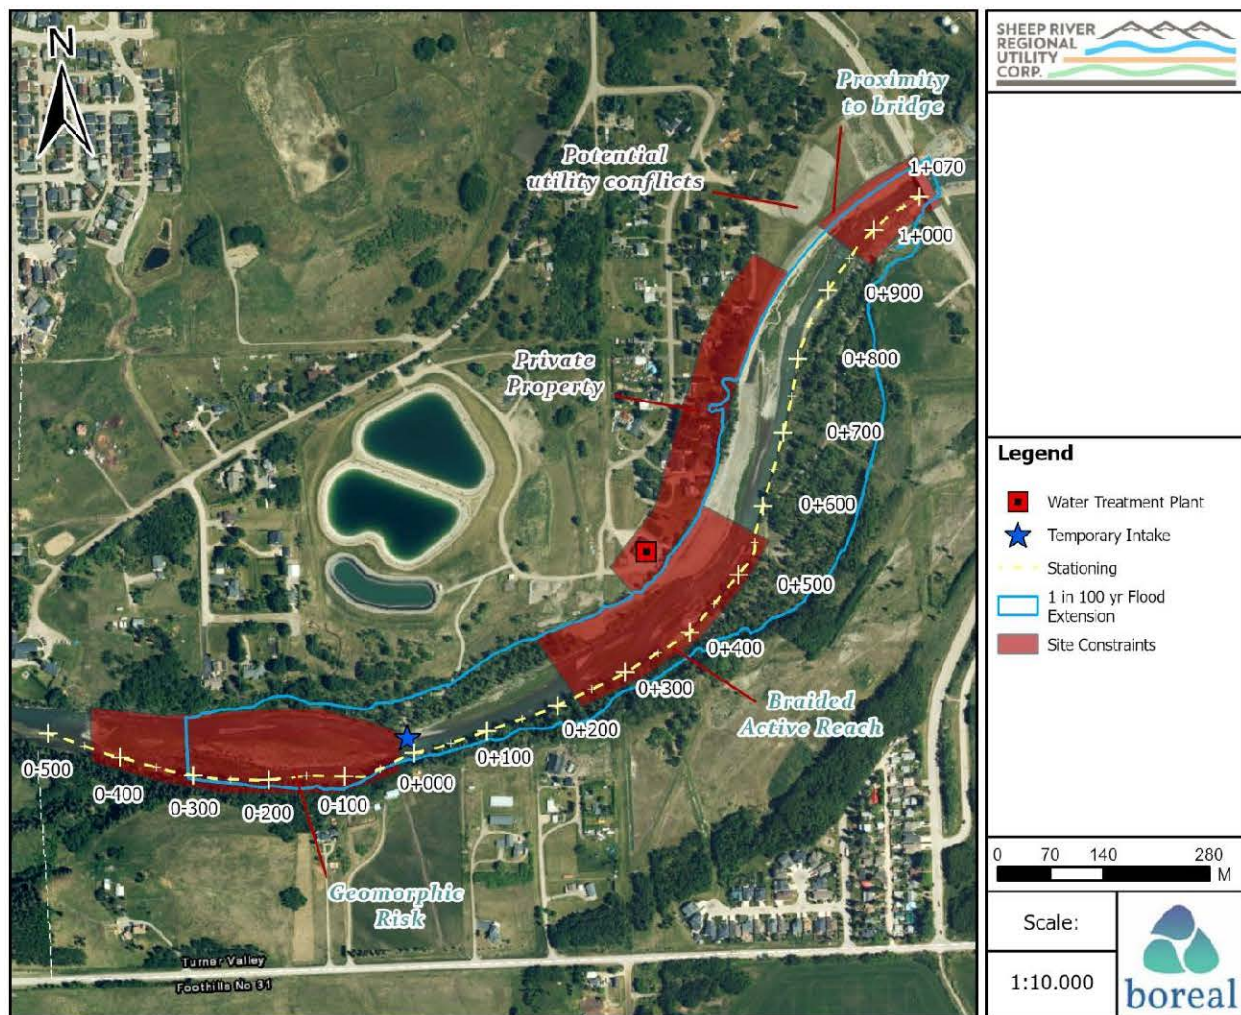
Figure E-2: Site constraints.
