Re: Sheep River Regional Utility Corporation (SRRUC) – EPEA Approval 1242-02-00 Application for Amending Approval No. 22 Direct Intake and Stilling Basin – Supplementary Information

Stantec Memo: Settling Pond Delineation Assessment – Interim Report June 30, 2017

Reference: Settling Pond Delineation Assessment – Interim Report

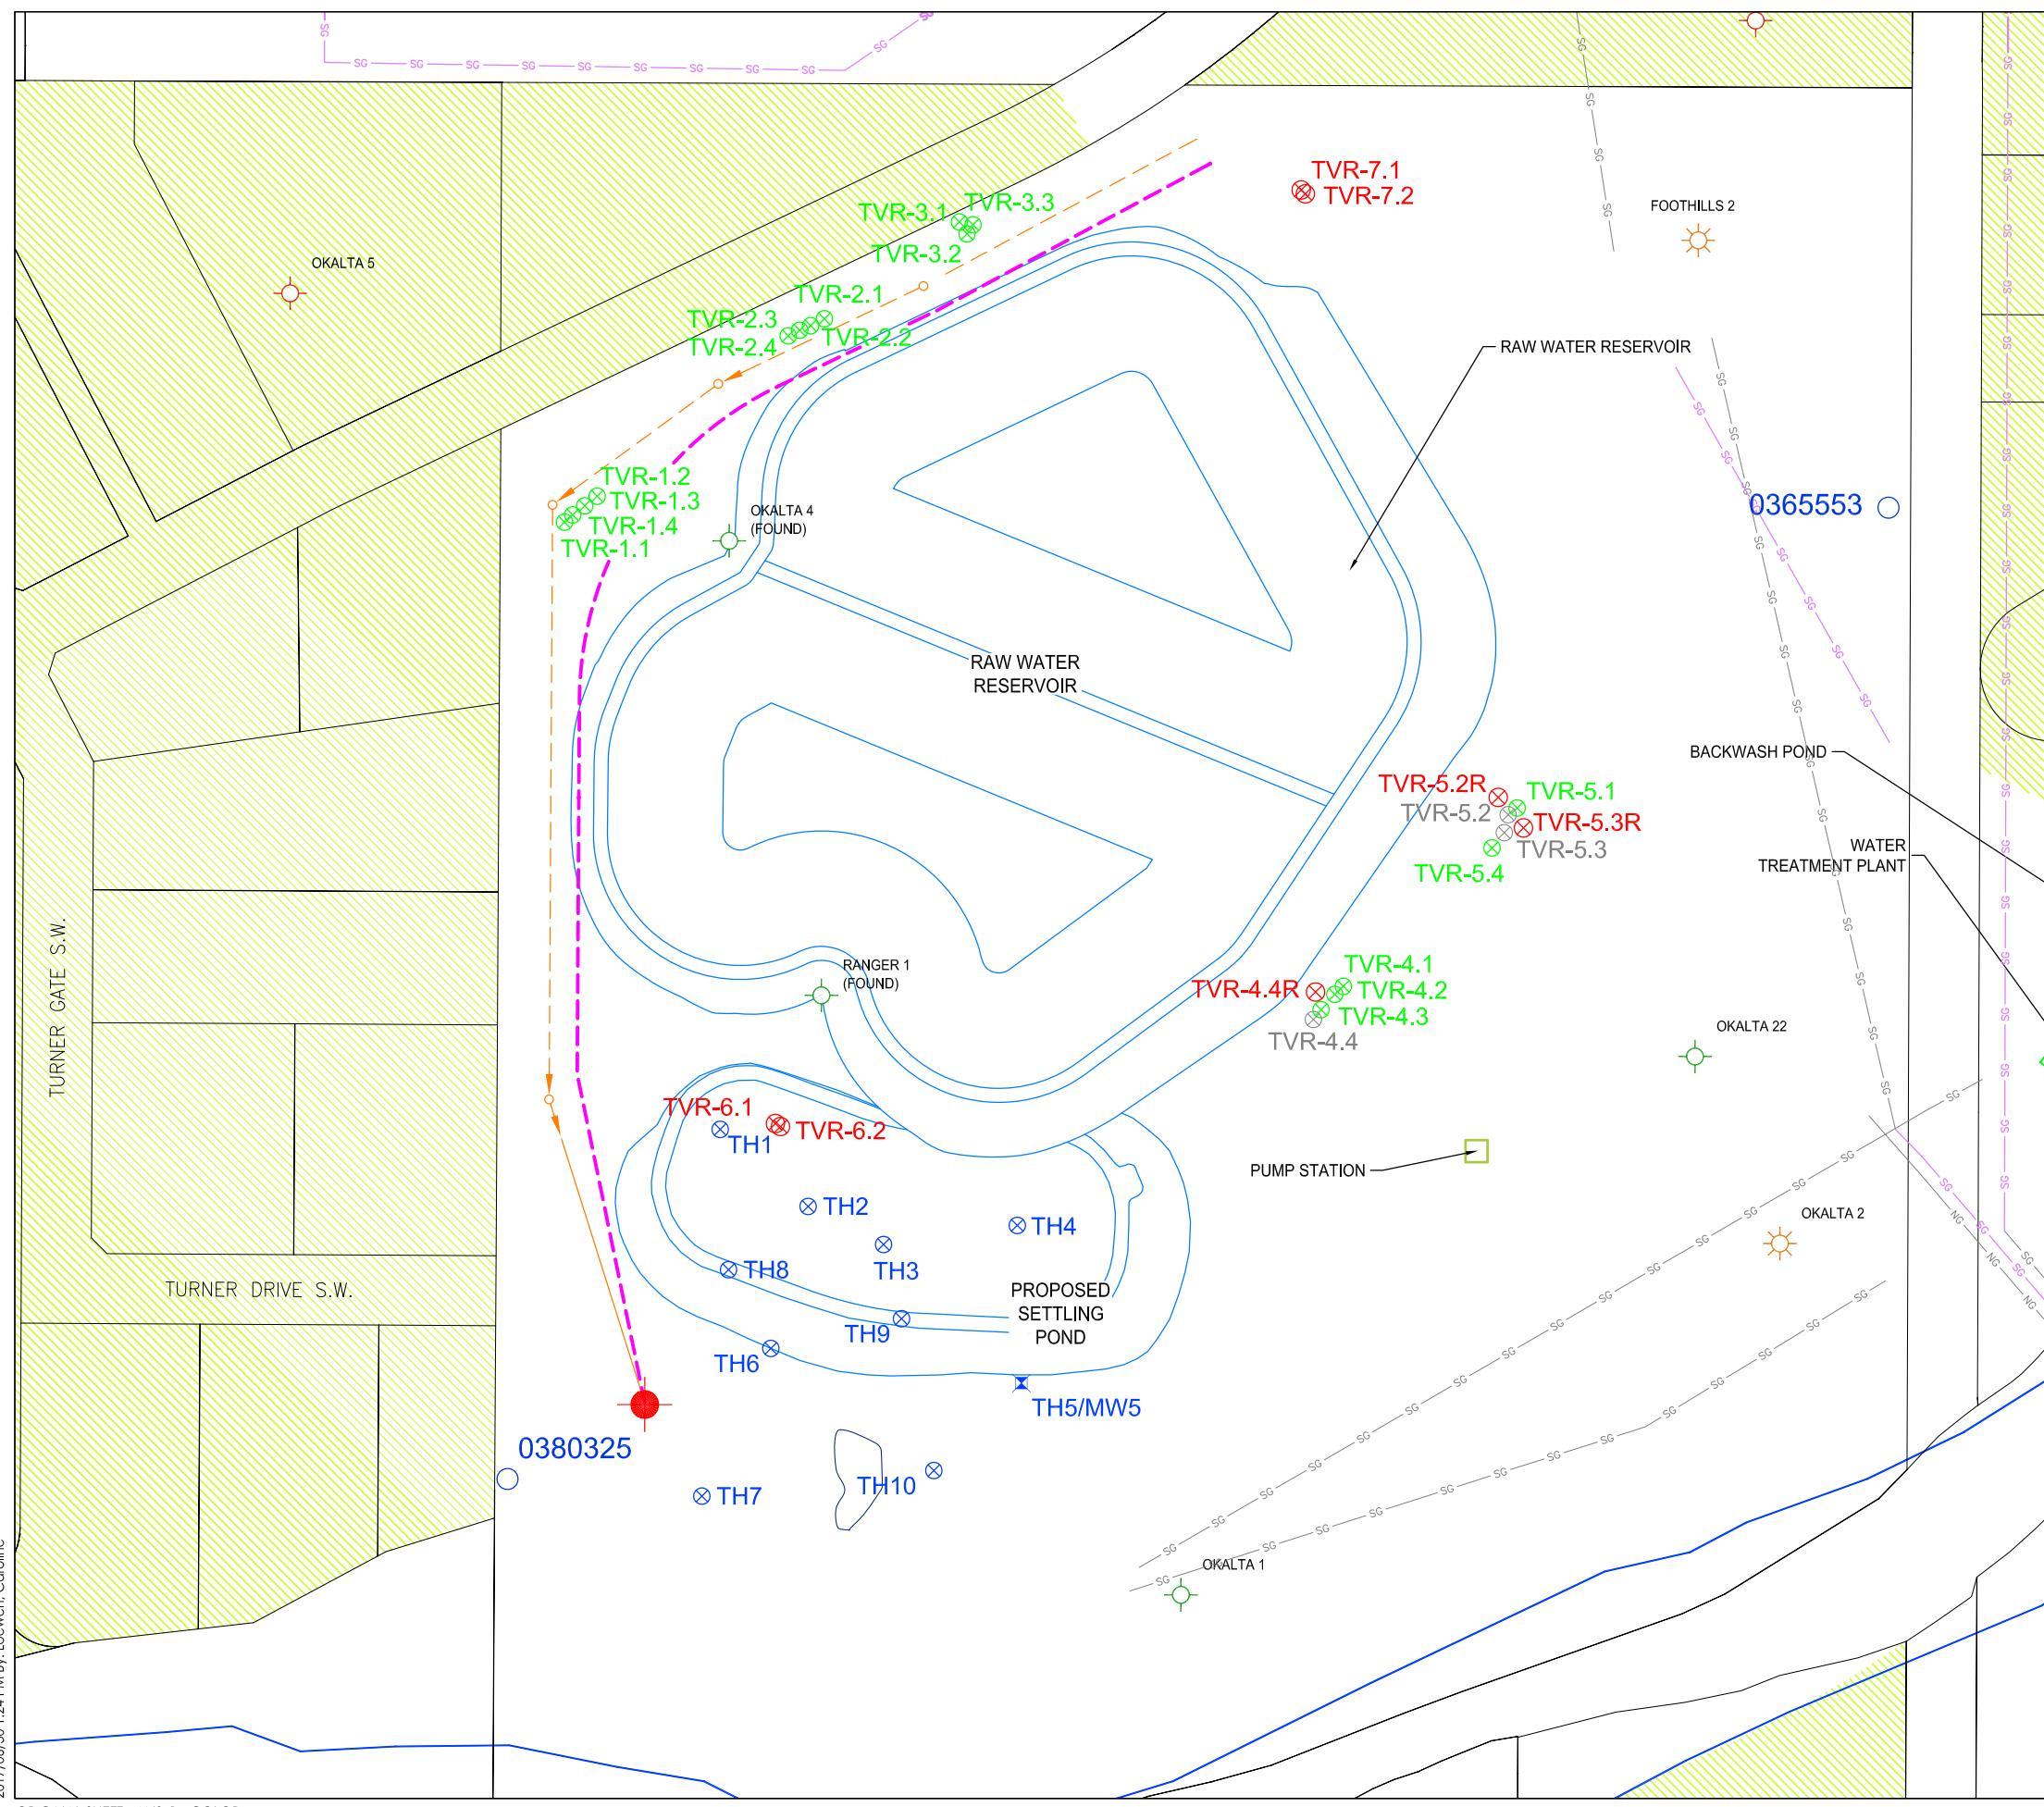
Stantec personnel were on-site on June 13, 2017 to conduct private utility locates, and again on June 15, 2017 to conduct field screening and soil sampling. Four test holes (TH7 to TH10) were advanced to a maximum depth of 6.0 metres below ground surface (mbgs) using a solid stem auger drill rig as shown on Figure 1, **Appendix A**. The test holes were advanced around test hole TH6 to further delineate soil impacts that exceeded the DUA pathway for ethylbenzene during the previous limited Phase II ESA. Stantec collected soil samples at regular intervals of approximately 0.75 m during test hole advancement and assessed combustible soil vapours in the samples collected. One soil sample per borehole, based on worse-case soil vapour concentration and/or field observations, was submitted for laboratory analysis of benzene, toluene, ethylbenzene, xylenes (BTEX), petroleum hydrocarbon (PHC) Fraction F1 to F4, PAHs, salinity parameters, and regulated metals, consistent with the previously conducted limited Phase II ESA. All boreholes were backfilled with soil cuttings and bentonite. Methods detailing the soil sampling are included in **Appendix B**.

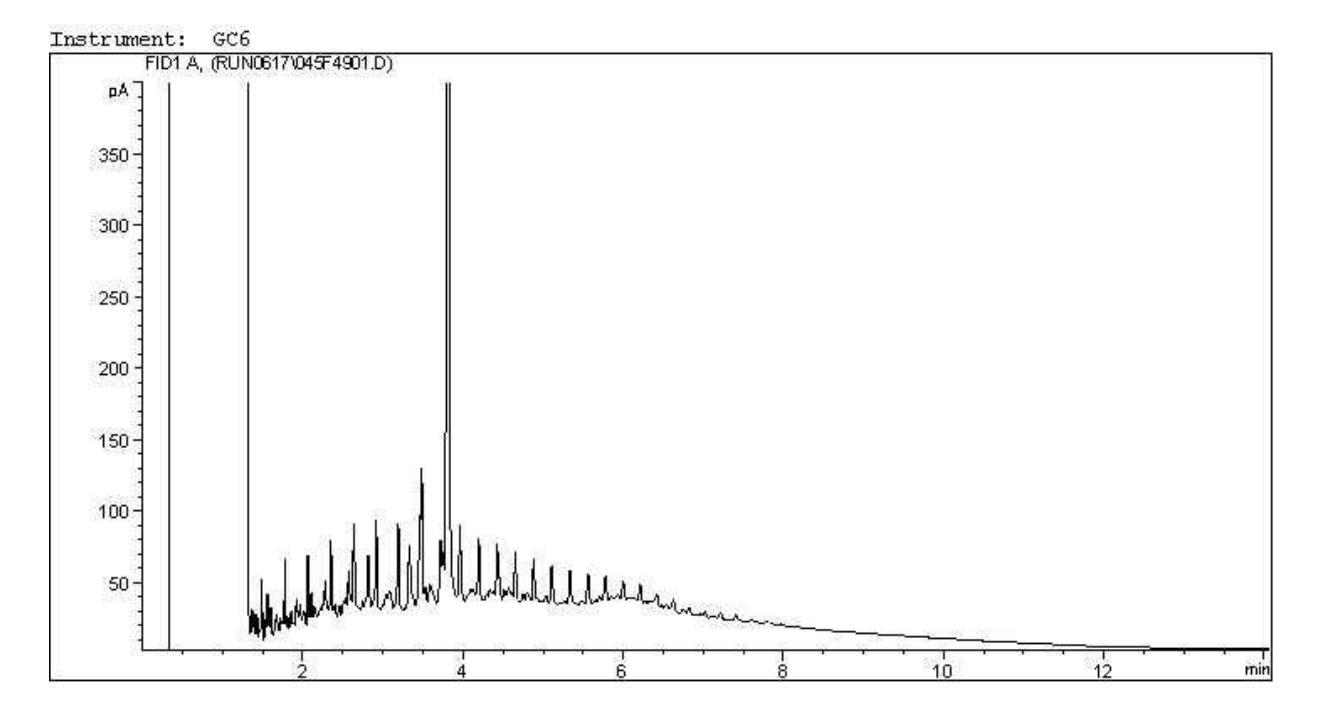
MPE ENGINEERING LTD. Client Project #: 123511754 Site Reference: TURNER VALLEY RESERVOIR PROJECT Client ID: TH7-SA-03

CCME Hydrocarbons (F2-F4 in soil) Chromatogram

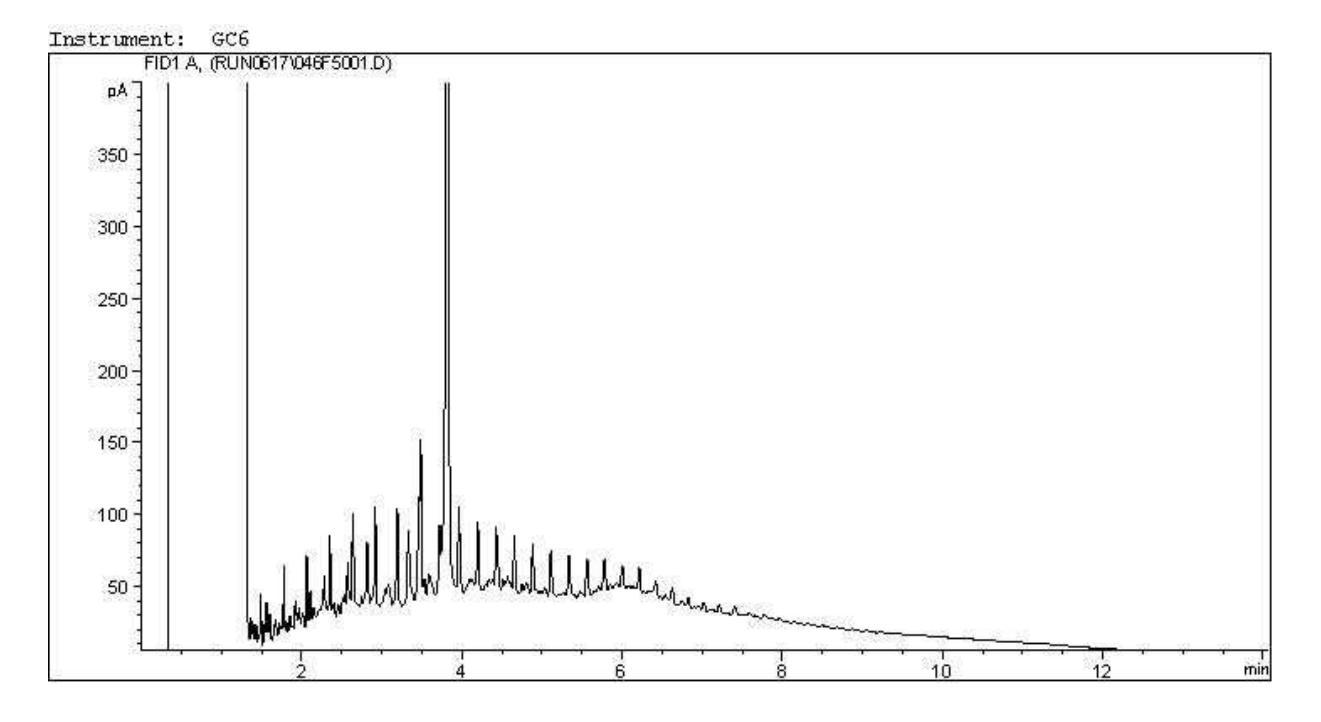
MPE ENGINEERING LTD. Client Project #: 123511754 Site Reference: TURNER VALLEY RESERVOIR PROJECT Client ID: QC-01

CCME Hydrocarbons (F2-F4 in soil) Chromatogram

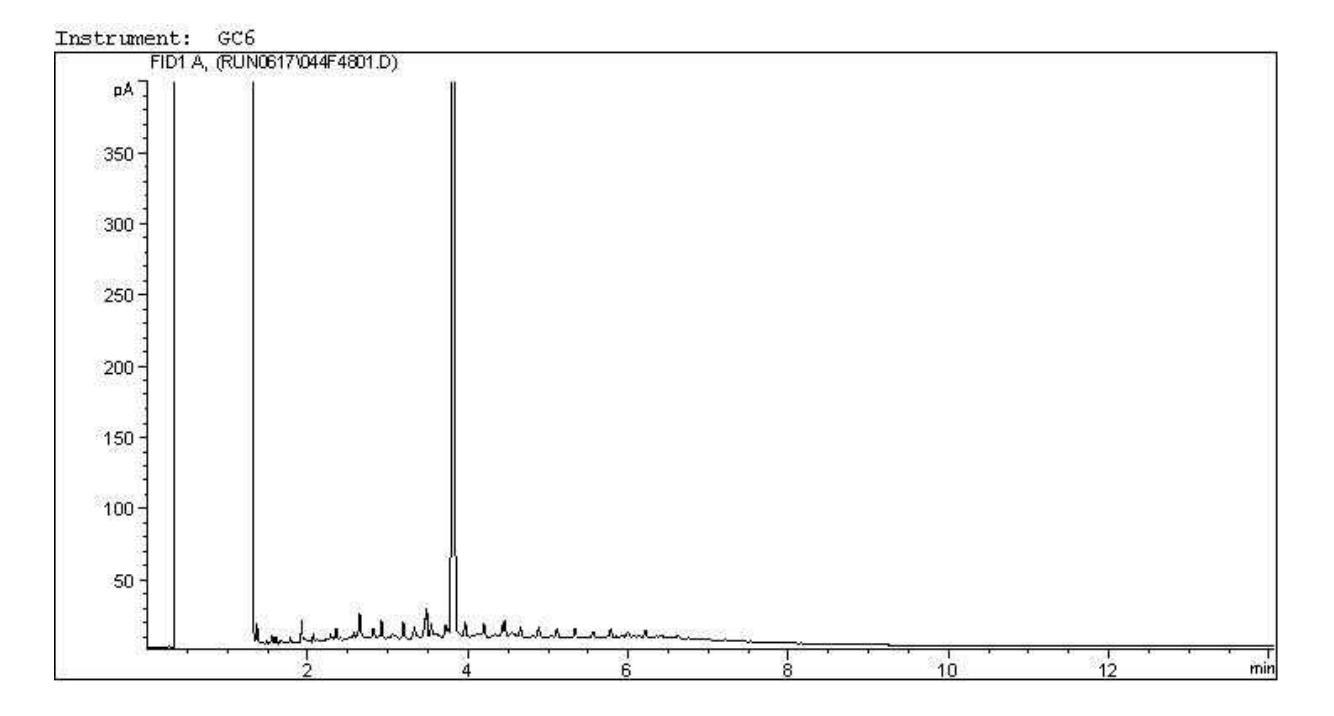
MPE ENGINEERING LTD. Client Project #: 123511754 Site Reference: TURNER VALLEY RESERVOIR PROJECT Client ID: TH8-SA-05

CCME Hydrocarbons (F2-F4 in soil) Chromatogram

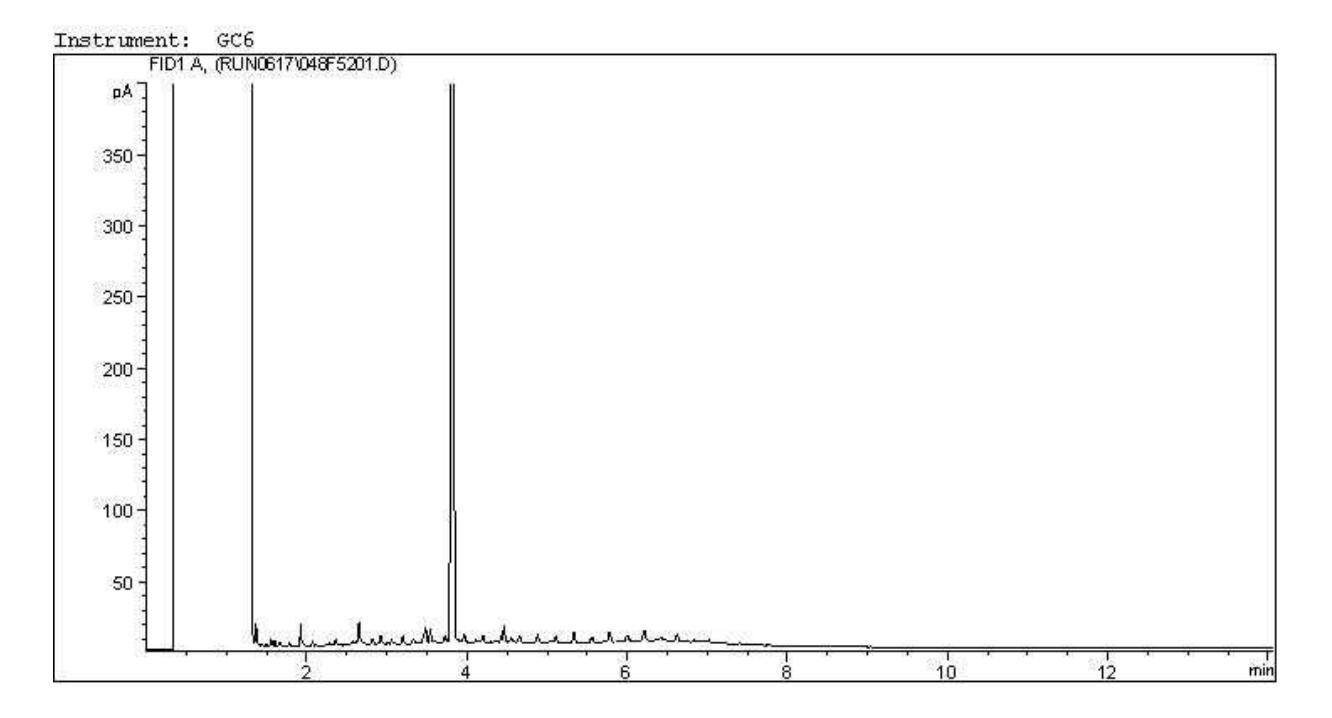
MPE ENGINEERING LTD. Client Project #: 123511754 Site Reference: TURNER VALLEY RESERVOIR PROJECT Client ID: TH9-SA-01

CCME Hydrocarbons (F2-F4 in soil) Chromatogram

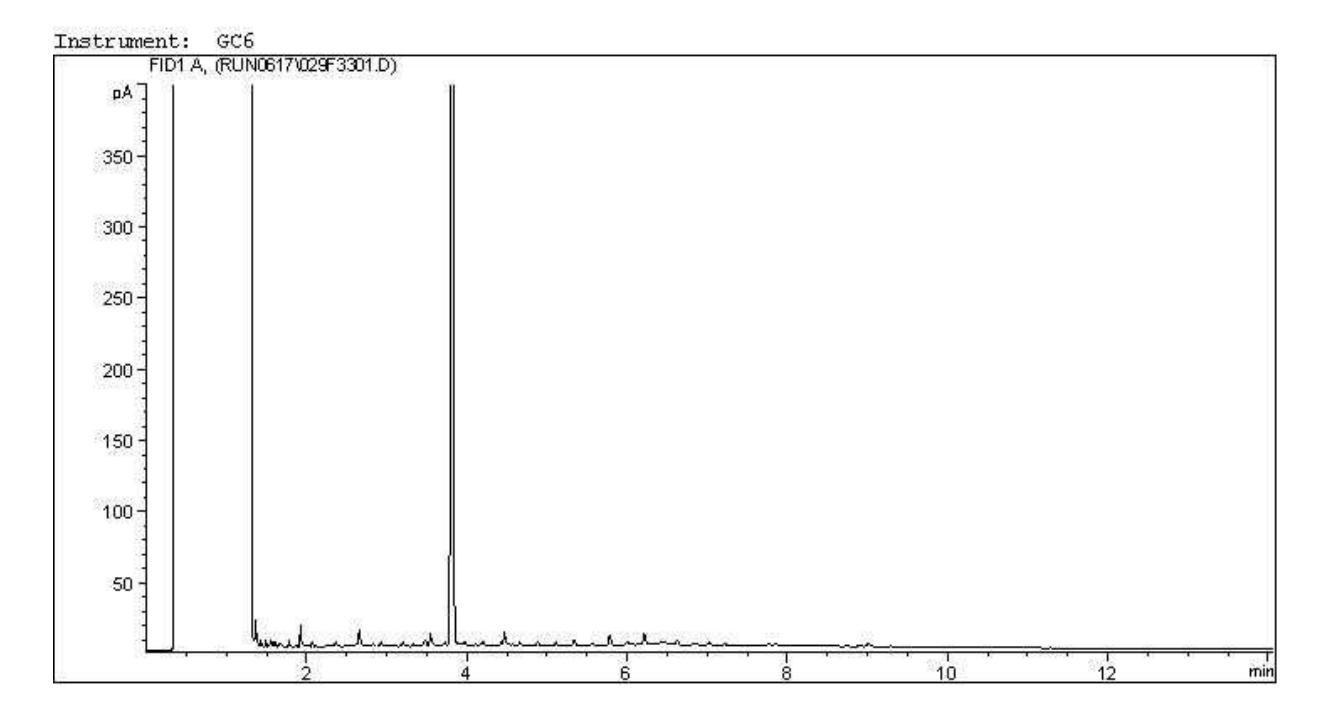
MPE ENGINEERING LTD. Client Project #: 123511754 Site Reference: TURNER VALLEY RESERVOIR PROJECT Client ID: TH10-SA-01

CCME Hydrocarbons (F2-F4 in soil) Chromatogram

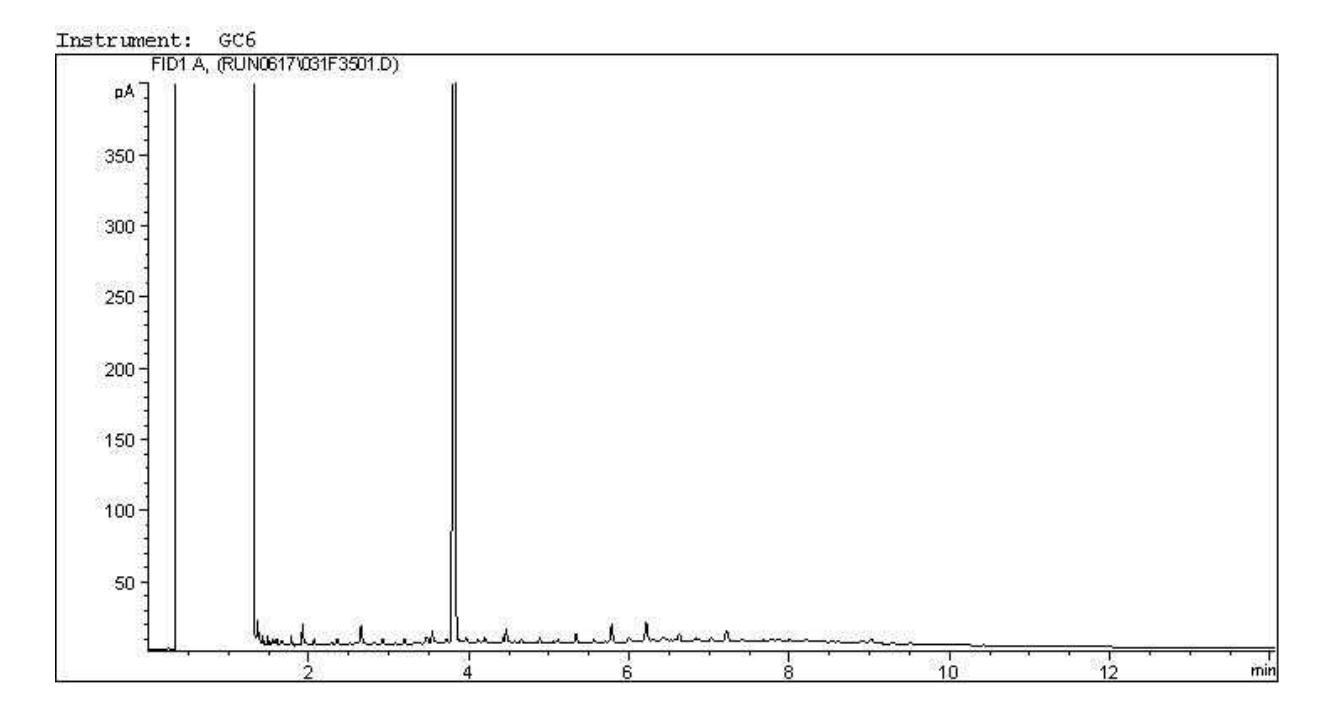
MPE ENGINEERING LTD. Client Project #: 123511754 Site Reference: TURNER VALLEY RESERVOIR PROJECT Client ID: TH10-SA-01

CCME Hydrocarbons (F2-F4 in soil) Chromatogram
